B.G.A. TECHNICAL COMMITTEE

TECHNICAL NEWSHEET

TNS 3/4/84

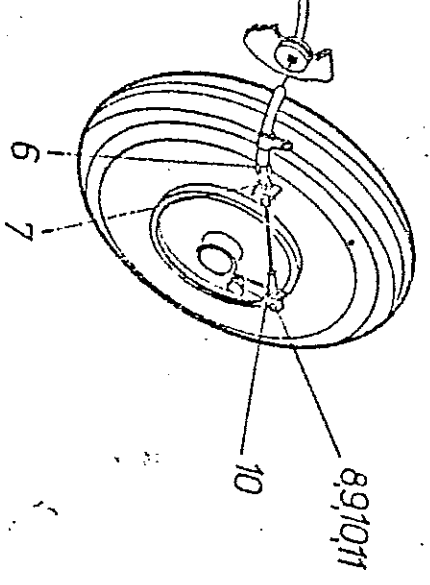
- 1.5. IS.28.M2 (Series) Defects reported to B.G.A./C.A.A.
  - a) Flap lever fouls floor in 5° position.
  - b) Airbrake micro-switch insecure
  - c) Landing gear selector lever centre bolt ripping the debris guard (cockpit)
  - d) Canopy flexes and jumps out of the guide rails.
  - e) Rudder pedal attachments to horizontal shaft by single rivet, prone to shearing.
  - f) Brake malfunction due to failure of flexible cable attachment bracket (sketch attached).

(A) Rubber Pad attachment,

(B) Brake cable bracket failure,
