BGA TECHNICAL COMMITTEE

TNS 7/8/85

PART 1 Airworthiness "Aggro" (Please add to the 1985 Green Pages)

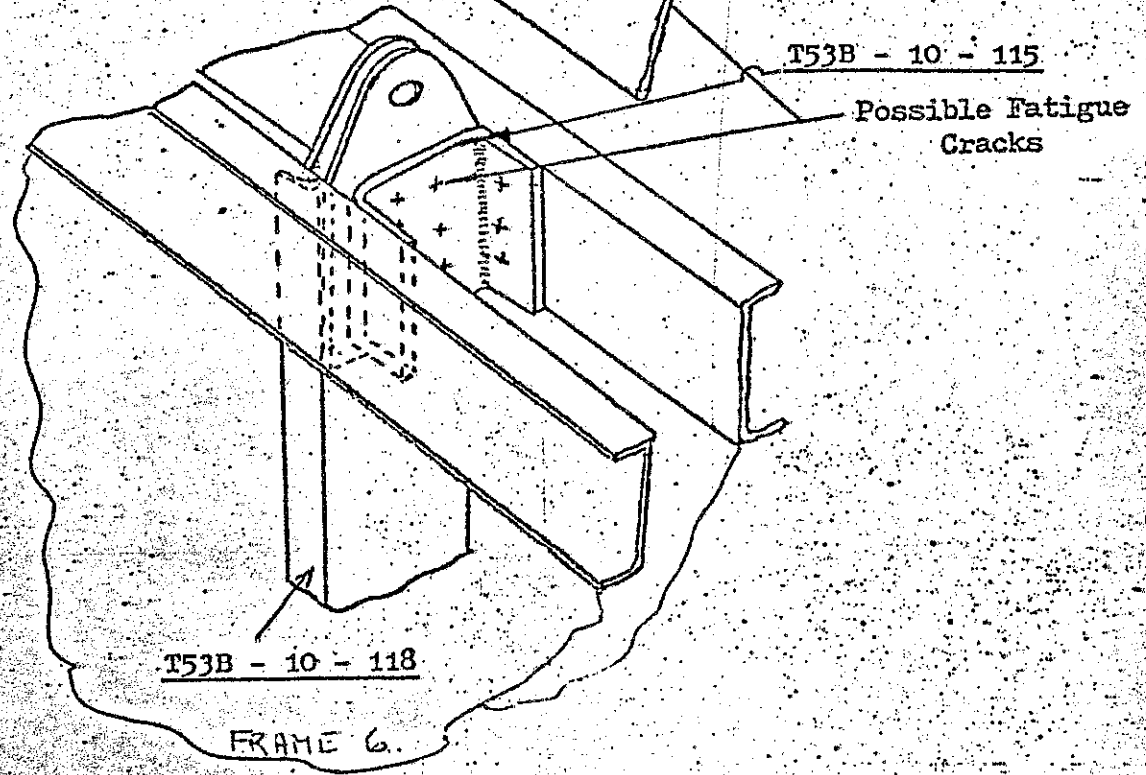
Figure 2

Remove glass fibre fairing No.T53B-10-1093 and wings if fitted. Using a Dye penetrant crack detection system, inspect for cracks at the corner of the fittings where the attachment flanges begin (a) the welded brackets Pt No.T53B-10-168 issue 1-4 see figure 1 page 2 which holds the rear spar member of the c/s to the fuselage frame 6 and (b) the alternative riveted bracket Pt No.T53B-10-168 issue 5. Also in a similar manner inspect the metal lugs T53B-10-115 and channel section T53-10-118 on frame 6. See Figure 2. Checking for cracks in way of rivets.	
If any cracks are found the aircraft is to be grounded. All findings to be reported to SEL marked for the attention of the undersigned. New components can be obtained from SEL if required as listed above. If there are no cracks the aircraft is cleared for flight.	
Once the inspection has been complete the TI 100/T53 action should be recorded in the aircraft log book.
