B.G.A. TECHNICAL COMMITTEE

TECHNICAL NEWSHEET

TNS 9/10/87

PART 1. AIRWORTHINESS AGGRO (Please add to the 1987 Green Pages)

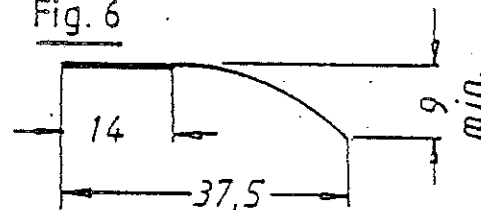
Fig. 6

Recently two ASW 20s had aileron flutter in flap position 1 at a speed of about above 200 to 210 km/h. The said ASW 20s were improperly equipped with an elastic plastic tape to seal the gap between wing and flaps/ ailerons on the under sides; they used strips of tape which were insufficiently curved, and above all the teflon strip which has to lie underneath for sealing the gaps, was missing. Owing to this, air exchange between wing upper side and under side is possible which causes - depending on the control surfaces' deflection - periodical separation of airflow and this unusual kind of aileron flutter. These latest findings also account for earlier flutter incidents which occurred mainly in countries with warm climate (see TN no.12). In those cases the gliders used insufficiently stiff plastic tape (partly even without fabric stiffening) which softened under high temperatures and therefore could crease periodically inwards and outwards thus causing varying airflow separation on the control surfaces under side and thereby leading to aileron vibrations. But also the factory-standard TESA fabric-tape (which is adequately plastic-treated) gets worn out after some time and then it has no more sufficient stiffness and may lead to the above described flutter incidents.

1. We recommend the fixing of an elastic lip sealing on the control surfaces gap, as both flight performance and flight characteristics are slightly improved by this.
2. The optional additional elastic lip sealing on the upper control surfaces gap does not require the sealing Teflon tape and so far no problems with this have been reported.
3. All actions under this TN can be accomplished by a competent person. The accomplishment of the "Action Point 3." must be certified by a licensed aviation inspector in the glider's inspection documents and in its logbook at the latest during the next annual re-inspection.
4. Maintenance Instruction J, Issue III, has been new revised for this TN and herewith becomes part of this TN.

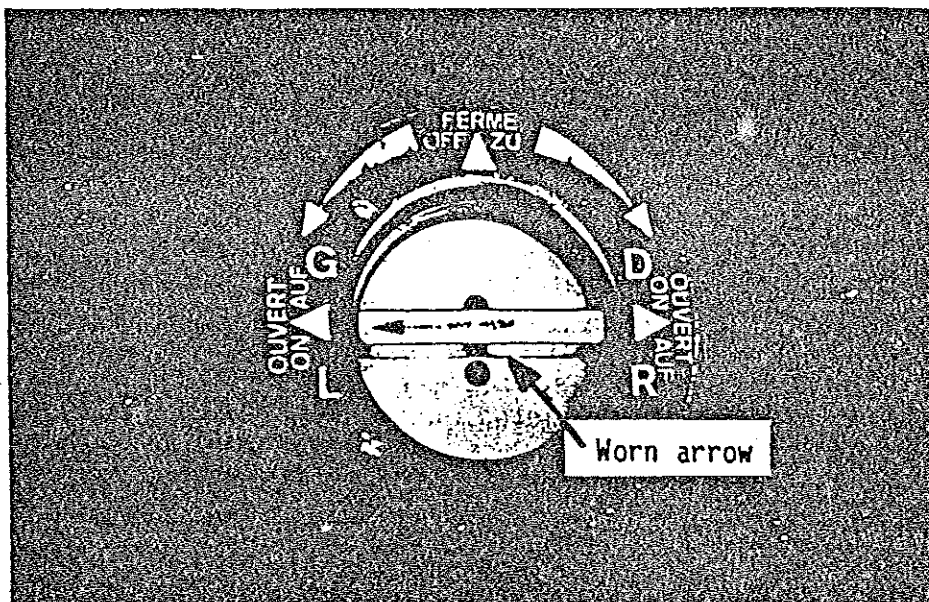
Accidents and incidents have been caused because of improper, imprecise or ambiguous markings on controls etc. in aircraft. Something that was satisfactory and clear when the aircraft was new, can easily become worn as the aircraft is used. The photograph below shows the worn markings of a typical Rallye fuel selector, which is on the floor where it gets worn by pilots entering and leaving the aircraft. This selector at first glance could be in either the left or the right tank position. Fuel selectors are often hidden in dark or out of the way places and not easily checked.
