B.G.A. TECHNICAL COMMITTEE.

TECHNICAL NEWSHEET.

TNS/3/4/88..

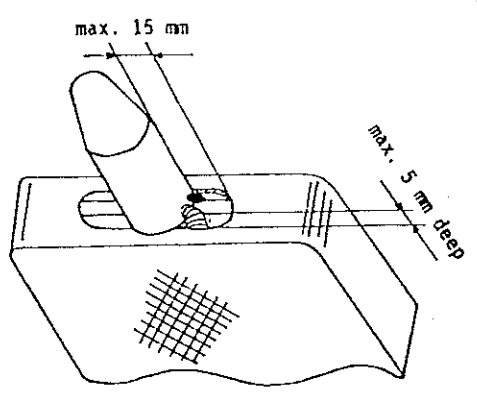
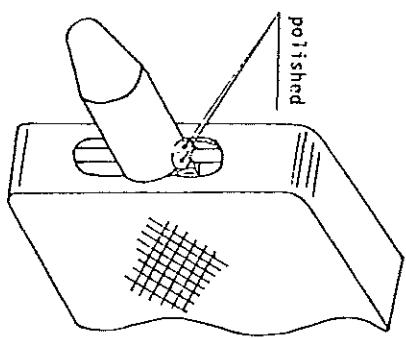
To perform the crack inspection the section of the wrapping around the main spigot has to be removed (max. 15 mm) and the adhesive material removed to expose the welding seam (max. 5 mm deep, see figure). Be very careful not to scratch or otherwise damage the spigot or plate.

If the weld seam is continuous around the plate, the complete toe of the welding seam has to be inspected. Grooves or nicks in the surface of the welding seam which are not part of a crack must be polished out and the crack inspection performed again.

A crack may be blended out if the following conditions are fulfilled:

- * crack on one side not deeper than 0.75 mm
- * cracks on both sides not deeper than 0.5 mm each

Finally apply a coating of resin to the exposed area (wood and metal).
