B.G.A. TECHNICAL COMMITTEE

TECHNICAL NEWSHEET

TNS/5/6/88

PART 1 AIRWORTHINESS "AGGRO". (Please add to the 1988 Red Pages)

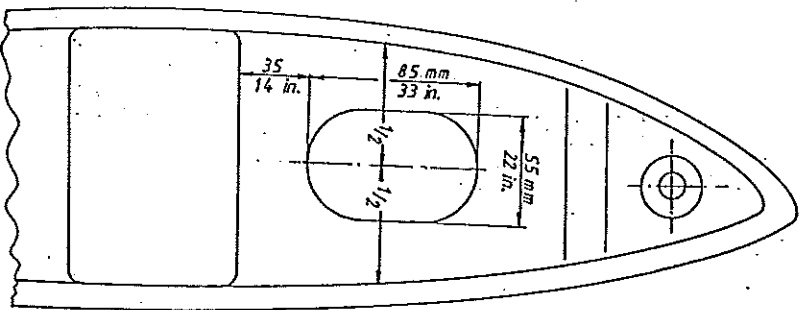
1.2 For this job you have to drill a hole through the opening in the root rib for the waterballast, using a drill of about 200 mm length (diameter according to the thickness of the endoscope). The endoscope with which the inspection of the spar inside can be done, has to be inserted into this hole (see Fig. 2). With ASW 15 gliders up to the serial no. 15183 there is no opening in the front root rib which, therefore, must first be drilled in this location (see Fig. 1). If you do not have an endoscope available, you can alternatively drill an opening of ø 28 mm.

2.1 As shown in Fig. 3, the wing spar inside must be inspected, using an endoscope (or a suitable mirror with suitable lighting mechanism, e.g. pocket-lamp bulbs soldered on with two stiff, approx. 1 m long wires) for discoloration and for wood-destroying mould fungi: the endoscope has to be inserted through the inspection holes which you have to drill (move the source of light along the spar inside). With ASW 15 gliders up to the serial no. 15183 you have to first drill an opening into the front root rib in accordance with Fig. 1 (this opening already exists on all gliders with serial no.s above 15183).

Nur gültig für ASW 15 bis Werk-Nr. 15 183 !
 Only required for ASW 15s up to the serial no. 15183 !

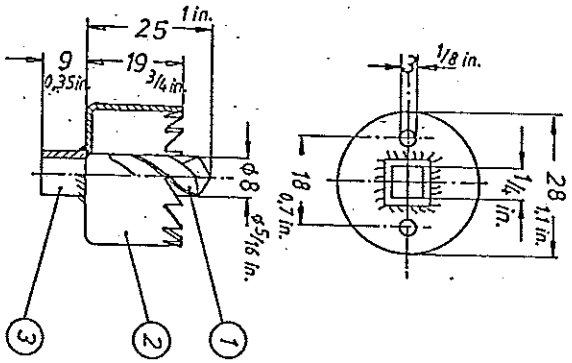
- (1) Twist drill $\phi 8$ mm
 (2) Keyhole saw $\phi 28$ mm
 (3) Female square socket $1/4$ in.

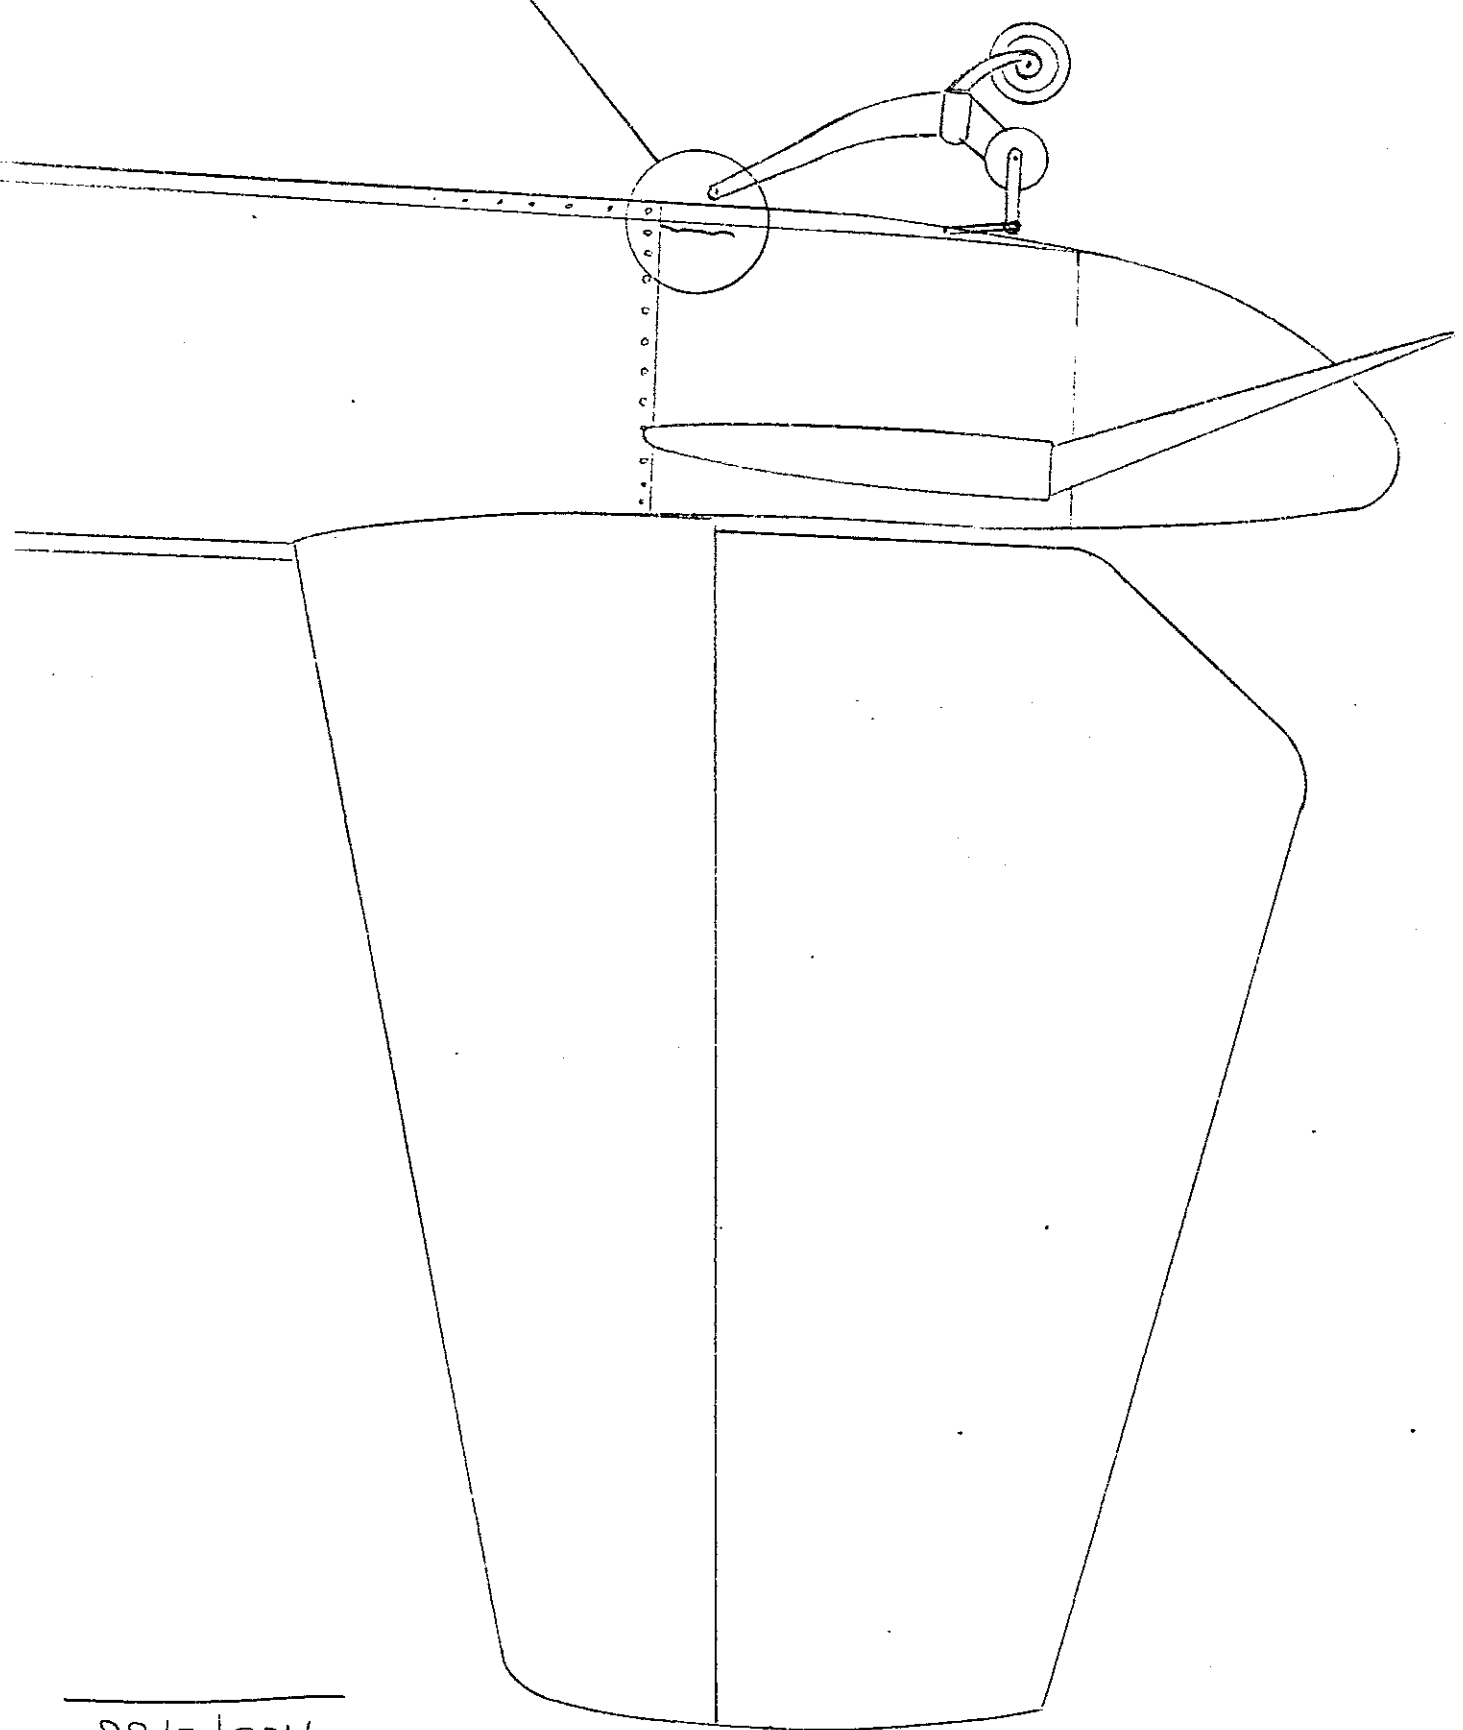
BLANK SKID MECHANISM & KOPAK

1.2 Putchatz - Top Rudder Hinge Failure, probably due to tail skid impact damage. The attached sketch recommends areas for inspection, and the introduction of a T.21 skid rubber to the tail skid. (Reported by P. Marks).
