B.G.A. TECHNICAL COMMITTEE.

TECHNICAL NEWSHEET.

TNS/7/8/88.

- PART 1 AIRWORTHINESS "AGGRO". (Please add to the 1988 Red Pages).
- 1.1 Grob G103 Twin Astirs/Accros. - Main wing spigot failure during fatigue test. The attached note was circulated to all owners. A Grob Working Party is currently changing these in the UK. Contact John Adams 0889/270577.

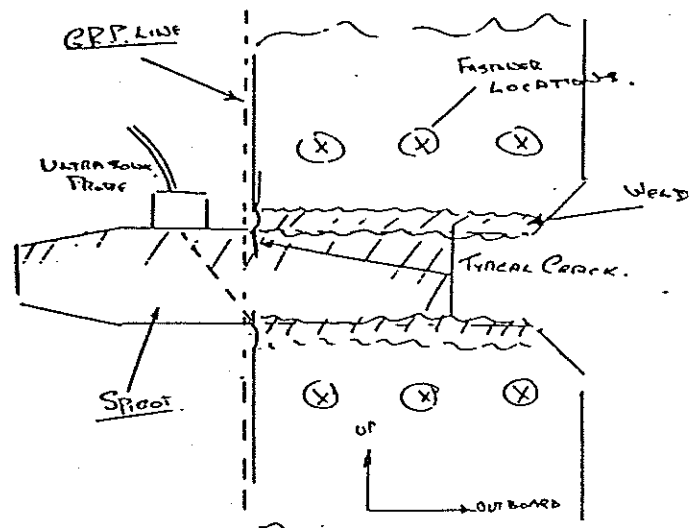
TECHNIQUE OR JOB DESCRIPTION
Request for investigation of possible cracks in spar end spigot, at the end of the weld attaching verticle anchoring plates to spigot. This area is covered by G.R.P.

- Following telecon with R.A.F. Swanton Morley the pins were examined by an ultrasonic shear wave technique described.
- LH & RH spar spigots gave crack indications, top and bottom, weld ends.
- G.R.P. was ground away (about 0.2") to expose the plates and welds.
- Weld ends were mag/particle inspected.
- Right wing - top weld - crack 0.4" long.
- bottom weld - crack 0.4" long.
Left wing - top weld - crack 0.5" long.
- bottom weld - crack 0.34" long.

Cracks appear to run into spigots. Depth unknown, unless progressively ground out and M.P.I. inspected until no crack remains, then measure.

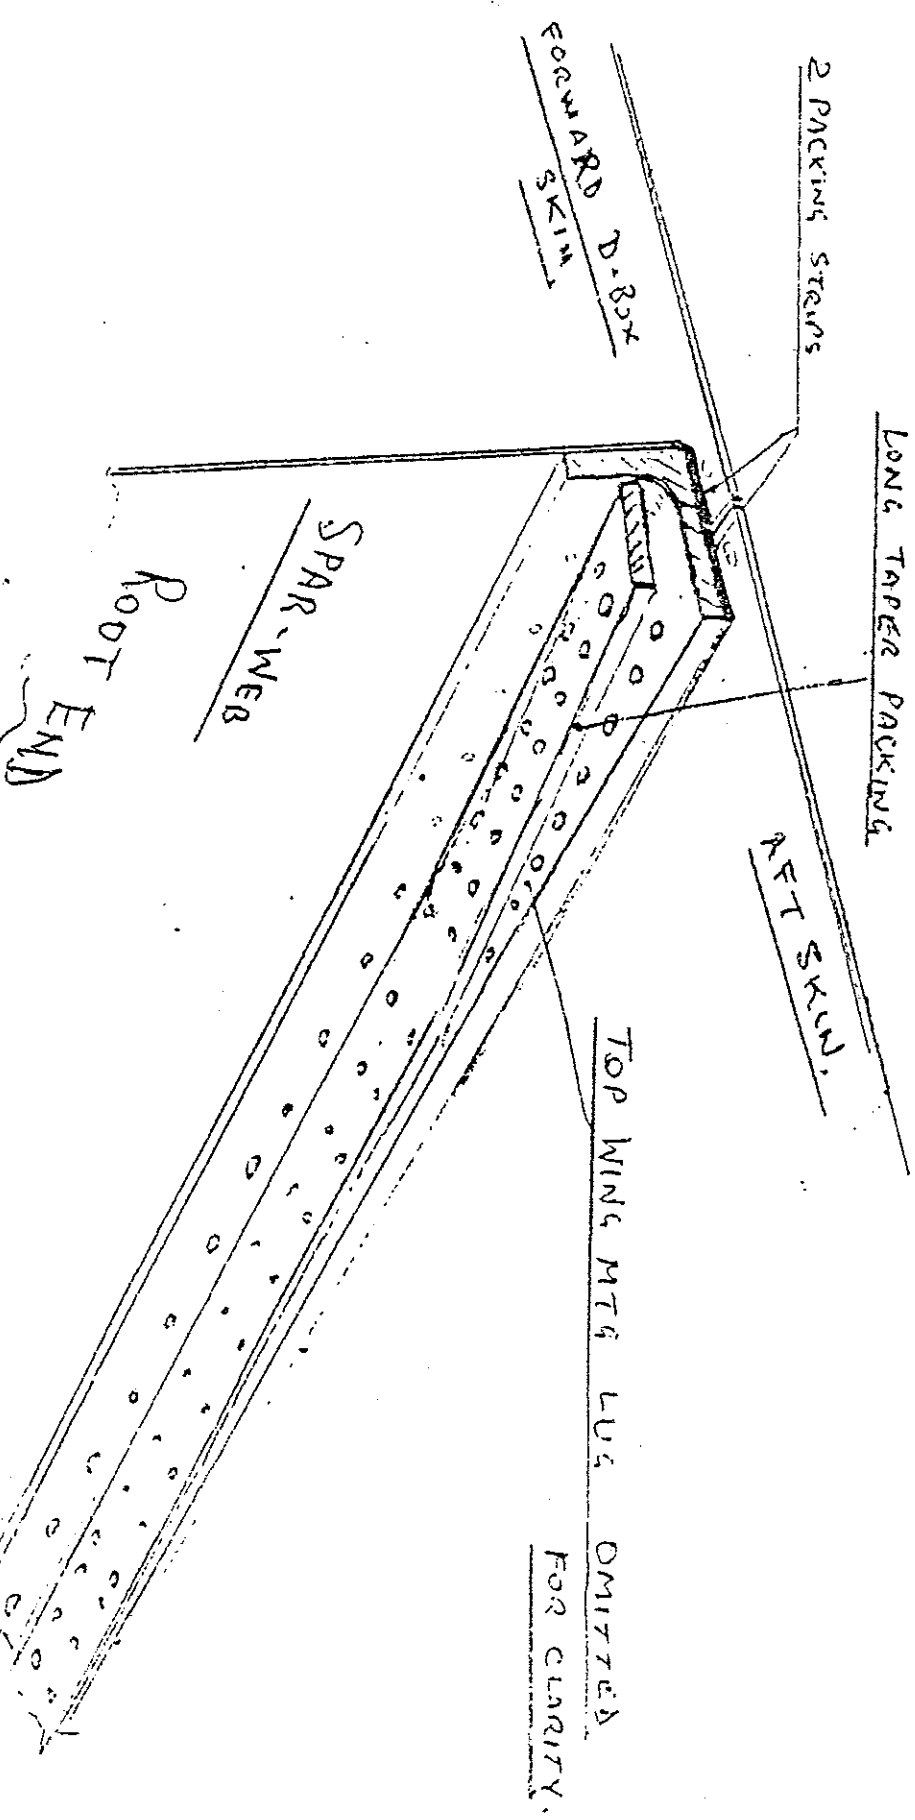
SUBJECT: BLANIK PORT WING: CORROSION IN UPPER SPAR BOOM AT ROOT END

On inspection of Port wing upper surface buckling of skin between rivets on mainspar joint observed. Rivets also showed strain signs with loose heads. Further inspection, internally, indicated some evidence of corrosion at spar boom extruded angle. On stripping down removing section of boom angle, severe exfoliation of Dural angle was exposed. Corrosion was limited to the angle only (reference Photographs already provided). Other Dural parts in contact with corroded parts showed little or no corrosion. Only the long taper packing showed damage (cracks) caused by the swelling affect of the angle. Laboratory tests of offending piece (Lucas Aerospace) showed no indication of contamination from external sources. It was considered that the angle was breaking down internally by normal process. Stress corrosion was considered but not supported by any indications from other sections.

British Aerospace Warton Materials Laboratory: Confirm that the exfoliation is the product of moisture ingress setting up electrolytic action, with consequent breakdown of extrusion material.

No trace of a 'GR' number or specification could be found on the section of angle removed. There is no evidence of wet assembly technique being used.

Further signs of corrosion in remainder of Port Wing are evident. The extent of the corrosion makes this Wing unservicable. The Starboard Wing appears to be sound. Wing.

BECAUSE OF THE DRY ASSEMBLY METHOD IT IS MOST PROBABLE THAT WATER ACCUMULATES IN THE GAP BETWEEN THE 2 SKINS AND SEEPS UNDER THE 2 SEPARATE PACKING STRIPS. THE EXTRUDED ANGLE THEN BECOMES ANODIC AND BEGINS TO BRENE DOWN UNDER THE CORROSIVE CONDITIONS. ITEMS IN CONTACT WITH ANGLE SHOW NO SIGNS OF CORROSION.
