B.G.A. TECHNICAL COMMITTEE.

TECHNICAL NEWSHEET.

TNS 11/12/88

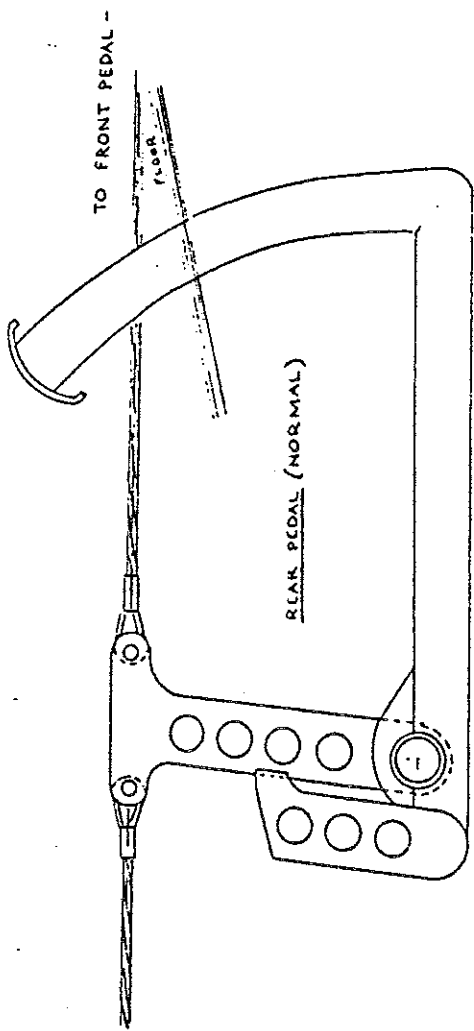
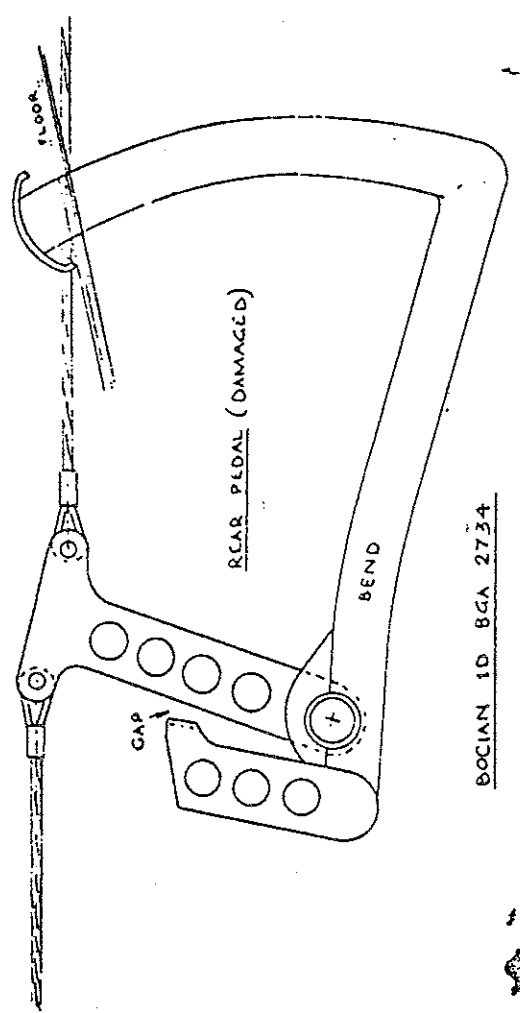
BOCIAN ID BGA 2734

- 1.5 KA7 / KA13 (KA7 conversions) cracking of the weld at the airbrake over centrelock. (Sketch by I.D. Smith is self explanatory).
- 1.6 Bocian Assymetric rudder pedal travel between front & rear cockpits. (The attached sketch by Tony Mos, Borders G.C outlines the problem).

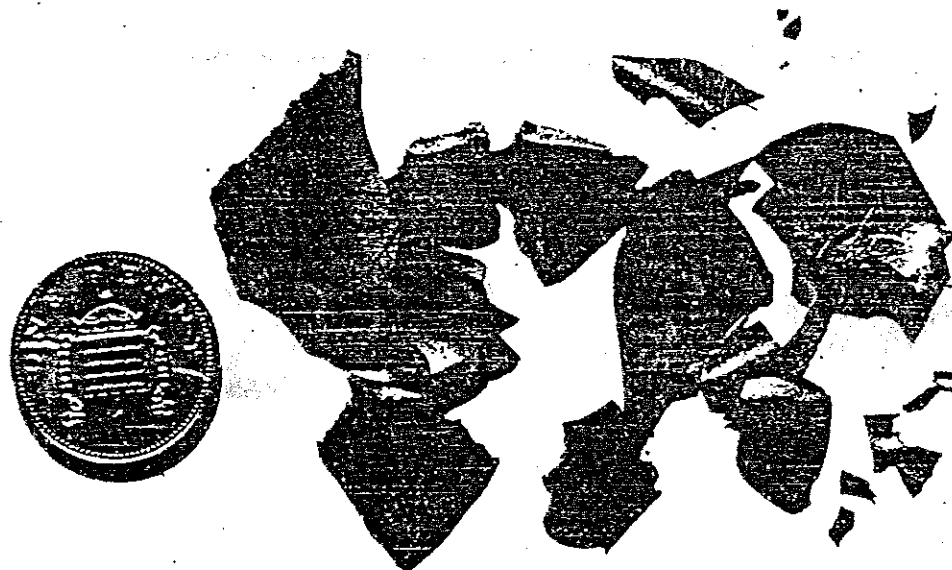
The SDAU recently received a letter from someone who purchased a quantity of new 'jerricans' from a company advertising in a well known mail order magazine. They appeared to be similar in every way to the standard military version.

However, he has noticed a tendency for the red sealing paint lining the inside of the cans, to detach itself from the steel and to be caught in the refuelling funnel and filter arrangement that he normally uses.

Whilst the stoppage of the lawn-mower engine through such contamination and blockage would be, at worst, inconvenient, the potentially disastrous results of such contamination and engine stoppage in an aircraft engine do reinforce the reasons for the safe-guards shown in Notice No. 98.
