BRITISH GLIDING ASSOCIATION

TNS 3/4/89.

PART 1 AIRWORTHINESS "AGGRO"

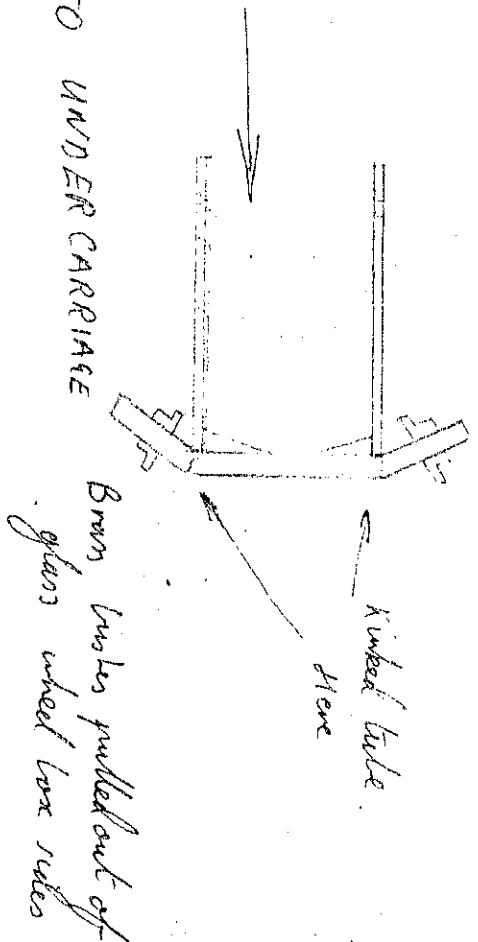
DAMAGE TO UNDERCARRIAGE

HEAVY LANDING.

DAMAGE TO LOWER RUDDER HINGE

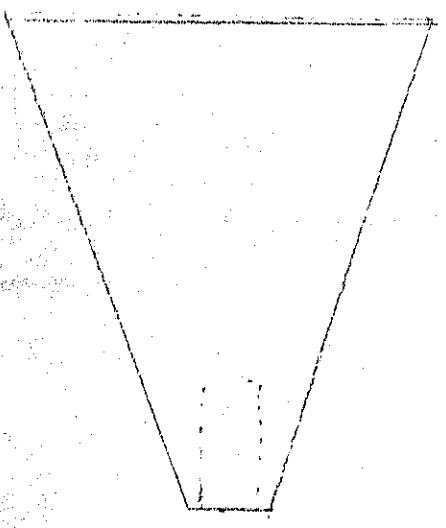
BLANIK.ITEM 18 UNDERCARRIAGE OLEO MODIFICATION. (G.F.A.Mod 88/12)

Approx extent of cracks shown.

Overhaul of the Blanik oleo strut often requires the replacement of the seals shown in the following diagram.
