B.G.A. TECHNICAL COMMITTEE

TECHNICAL NEWSHEET

TNS 7/8/89

PART 1 AIRWORTHINESS "AGGRO"

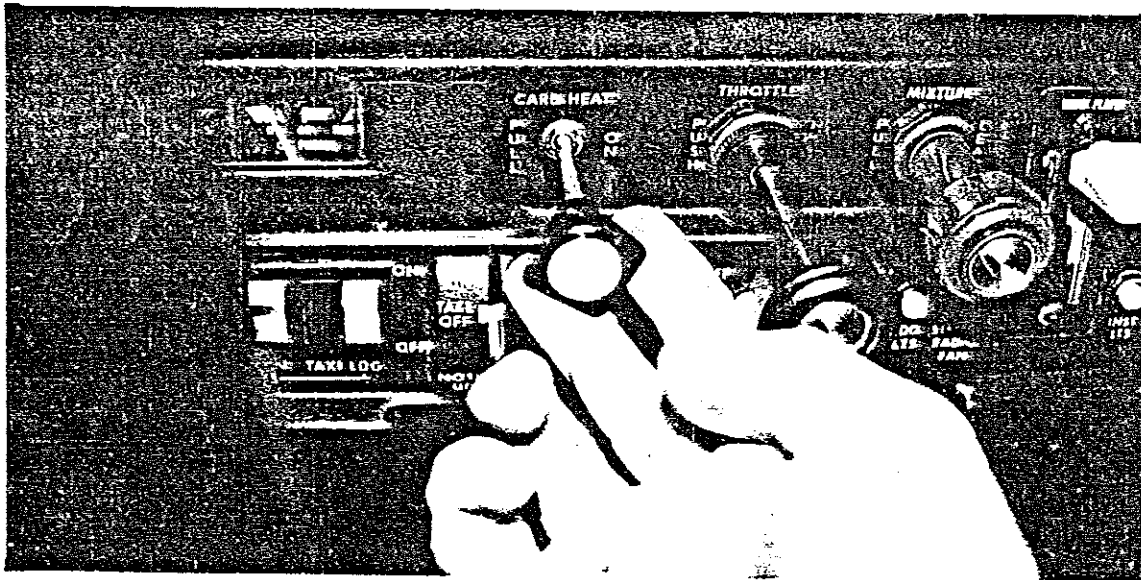
The aircraft was returning from a local flight and the pilot reduced the throttle setting for a descent to the airfield. On re-opening the throttle, the engine failed to respond and in attempting to reach the airfield, the aircraft struck some electrical power cables damaging the tailplane and severing the cables.

An aftercast of the weather that day showed that the air temperature between 3000 ft and 1000 ft rose from 7°C to 12°C with a humidity remaining at about 70%. These conditions would be conducive to carburettor icing even at cruise power. At reduced throttle settings, the tendency for carburettor ice formation would be even more severe.

Pilots must remember that in this country, particularly in the best of summers, (because warm air will hold more moisture than cold air) the possibility of carburettor icing always exists and regular use of carburettor heat must be borne in mind at all times. Furthermore, carburettor heat **MUST BE GIVEN TIME TO WORK**. It may take up to a minute for all of the ice to melt.
