BRITISH GLIDING ASSOCIATION

BGA TECHNICAL COMMITTEE

TECHNICAL NEWSHEET TNS 7/8/90

CAA EMERGENCY AIRWORTHINESS DIRECTIVE 004-06-90  
PIPER PA-25, PA-25-235 AND PA-25-260 AIRCRAFT  
INSPECTION OF TAILPLANE ATTACHMENT FOR CRACKS

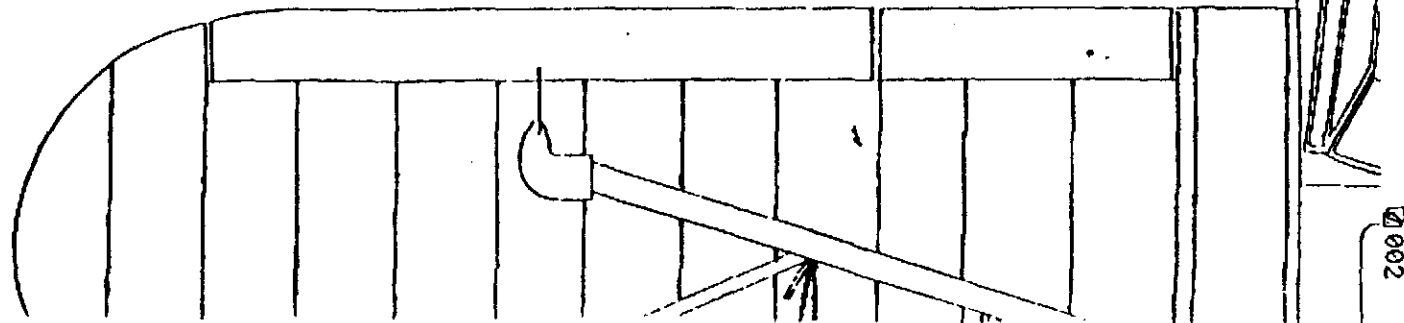
PA25-235

A report has been received of an in-flight failure of the tailplane attachment of a PA-25. Investigation revealed that the starboard forward fuselage-mounted attachment tube had suffered a fatigue failure at the point where the tube was welded to the fuselage structure. This Directive is issued to alert aircraft owners to the problem and to introduce a preliminary inspection. This Directive may be revised after a review of the findings from the inspection and when the problem has been discussed with Piper Aircraft Corporation and the FAA.

Inspect the upper and lower bracing wires for correct rigging. Remove both halves of the tailplane and peel back the fabric patches which cover the forward transverse tailplane attachment tubes. Inspect these tubes for cracks using a dye penetrant or equivalent NDT inspection technique acceptable to the CAA. Pay particular attention to the areas adjacent to the welds. Report all findings of both inspections, whether defects are found or not, to the CAA Safety Data and Analysis Unit giving details of the total number of hours the part has accumulated in service.

ADJUST TO OBTAIN  $.437 \pm .06$  DEFLECTION WITH LOAD APPLIED AS NOTED.

WITH AIRPLANE IN LEVEL POSITION & THE TAIL WIRES ADJUSTED AS NOTED ABOVE. THE REAR SPARS OF THE STABILIZER SHALL BE LEVEL; THE ELEVATOR HINGE LINE STRAIGHT. THE FIN SHOULD BE VERTICAL AT THE RUDDER  $\phi$ .
