BRITISH GLIDING ASSOCIATION

BGA TECHNICAL COMMITTEE

TECHNICAL NEWSHEET TNS 9/10/90

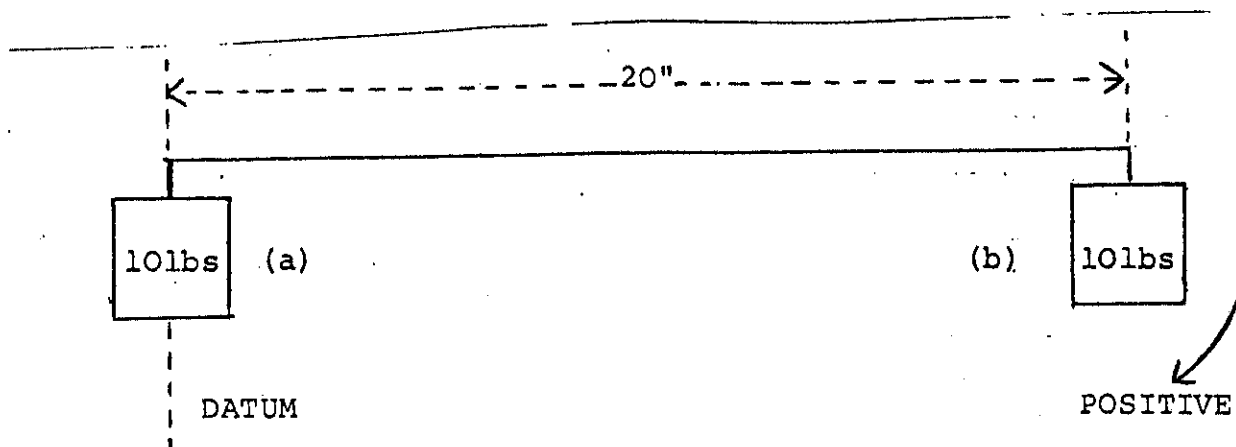
FIG 1

equipment is calculated by multiplying the weight of the equipment by its distance from the selected datum. If the turning moment is clockwise it is considered to be a POSITIVE moment and if anti-clockwise, a NEGATIVE moment. A simple example of determining C of G is shown in Figure 1.

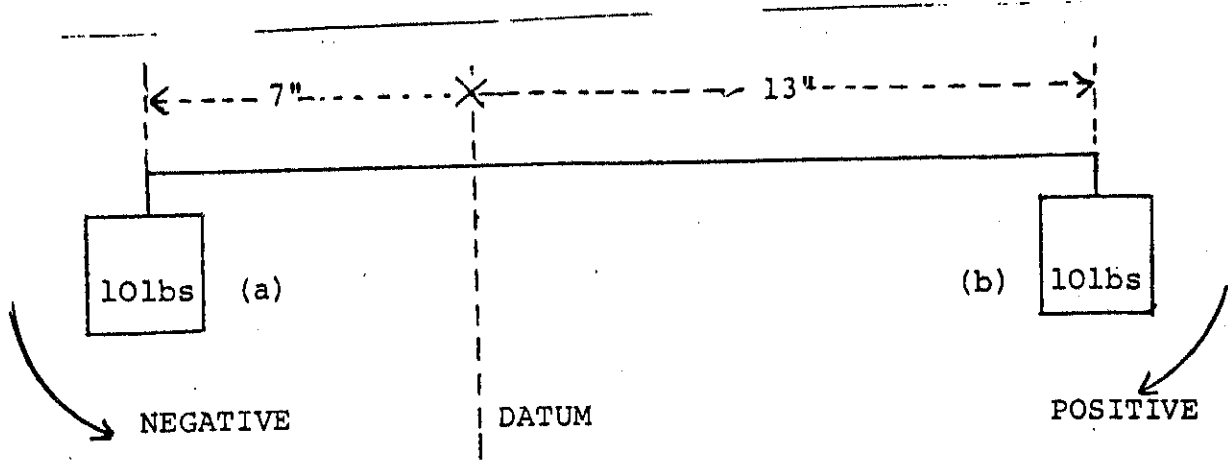
FIG 2

8. Provided all the moments are taken about the SAME datum, the position of the datum is immaterial as illustrated by Figure 2, which uses the basic values used in Figure 1.

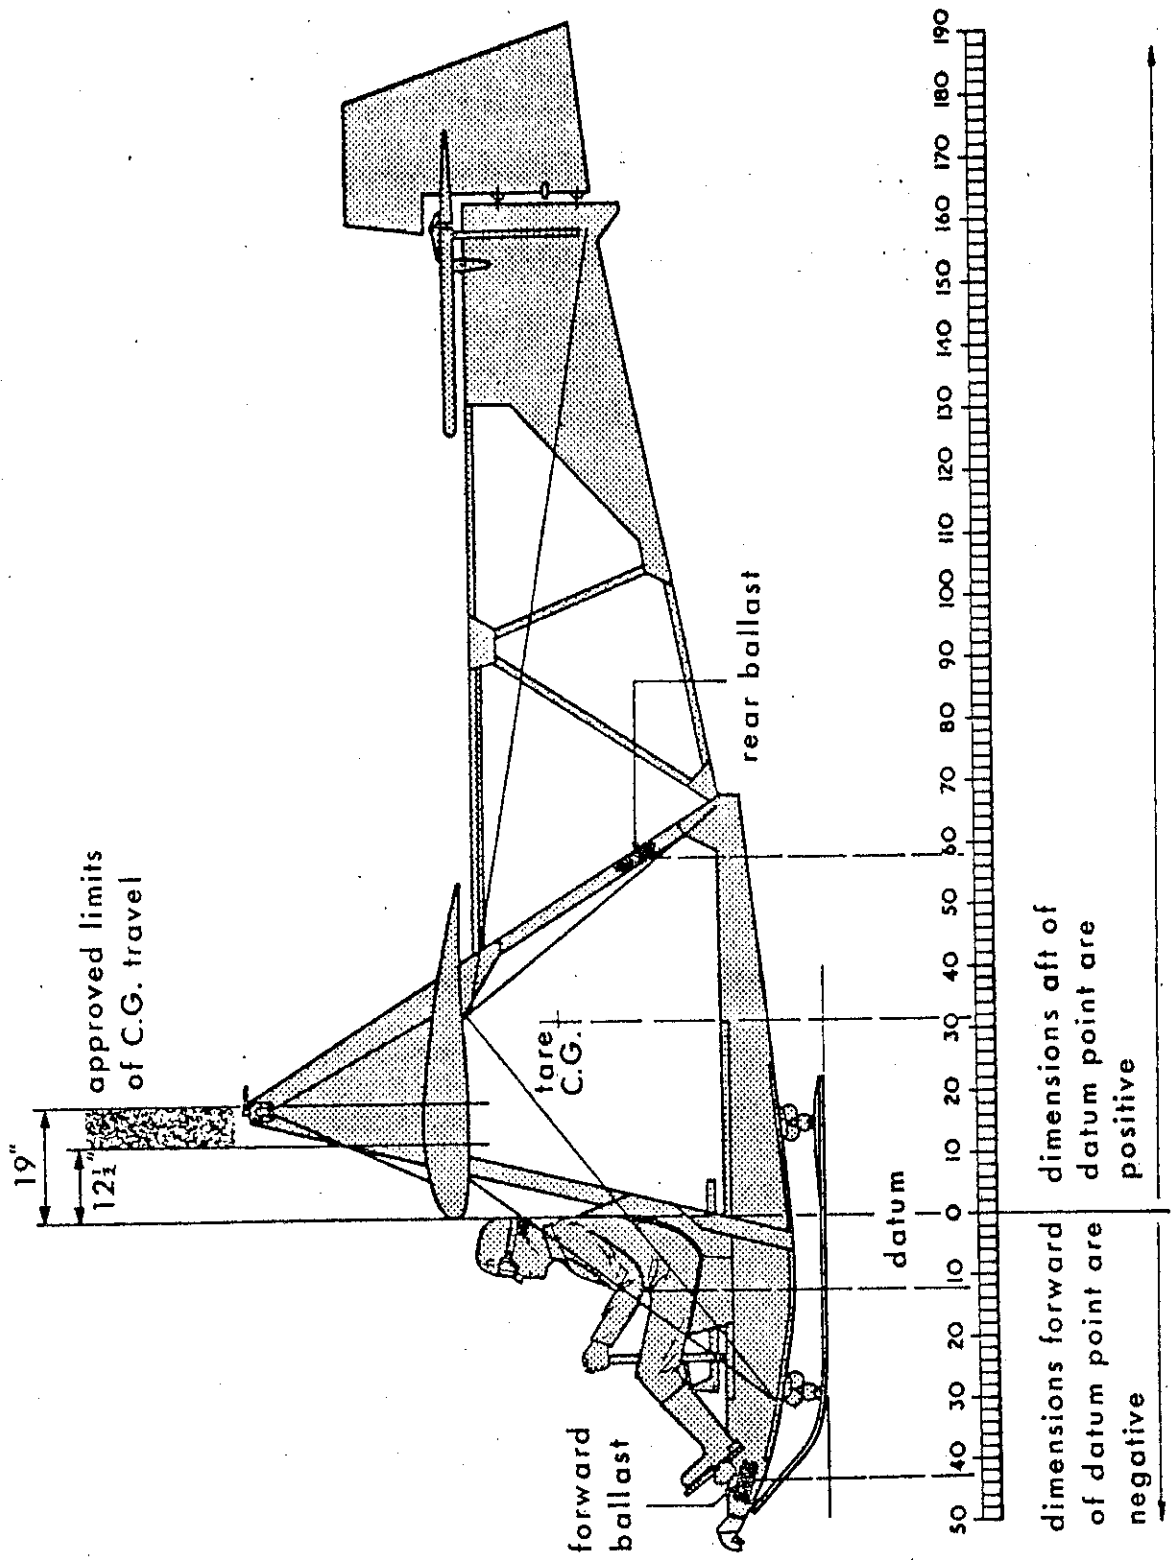
FIG 3 LOADING AND C G DIAGRAM

9. The manufacturers datum for the Grasshopper lies on a line perpendicular to the keel and tangential to the mainplane leading edge, Figure 3. The tare weight of a Grasshopper on manufacture is 287 lbs and the tare C of G is 31.2 inches on the positive side of the datum. When calculating the C of G of any aircraft, by convention, the aircraft is always considered to be facing left. Positive movements will therefore make the aircraft tail heavy. Negative moments will make the aircraft nose heavy. For safe operation, Grasshoppers must always be loaded so that the C of G remains within +12.5 inches and +19 inches of the datum. The ideal position of the C of G is +16.9 inches from the datum.

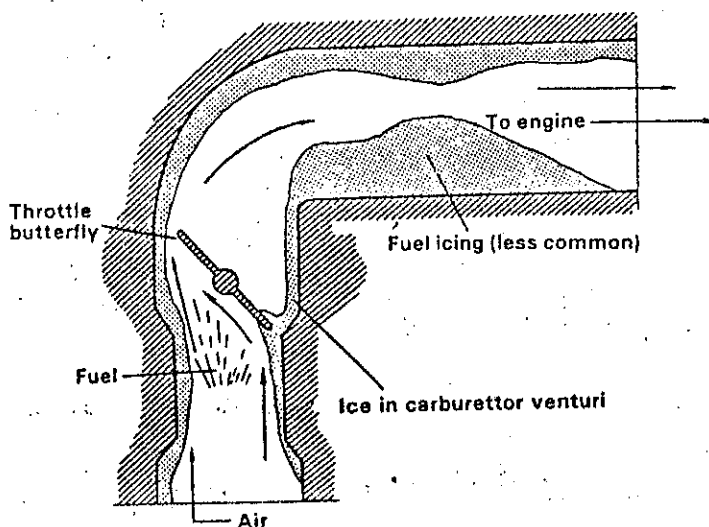
BUILD-UP OF ICING IN INDUCTION SYSTEM

The most common type of induction system icing is carburettor icing which is caused by the sudden temperature drop due to fuel vaporization and reduction in pressure at the carburettor venturi. The temperature reduction may be as much as 20° - 30° C and results in moisture in the induction air forming ice. The ice gradually builds up, constricting the venturi and, by upsetting the fuel/air ratio, causes a progressive decrease in engine power. Engines which have a conventional float type carburettor are more prone to this type of icing than are those which have a pressure jet carburettor, ie the Stromberg type of carburettor. Engines with a fuel injection system are not, of course, subject to carburettor icing.

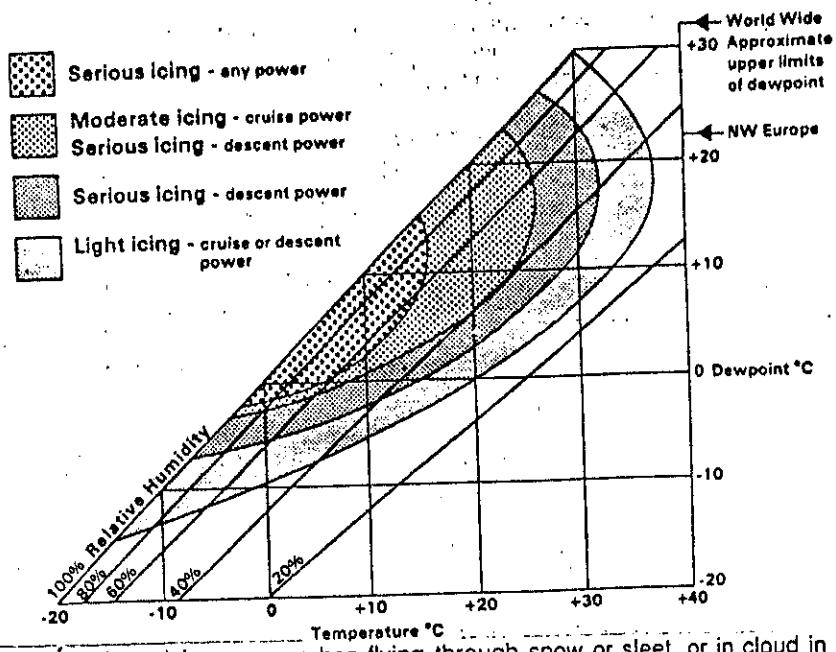
conductive to the formation of induction system icing for a typical light aircraft piston engine. Particular note should be taken of the much greater risk of serious icing with descent power. The closer the temperature and dewpoint readings the greater the relative humidity.

CARBURETTOR ICING IN AIR FREE OF CLOUD, FOG, OR PRECIPITATION
 -risk and rate of icing will be greater when operating in cloud, fog and precipitation.
