BRITISH GLIDING ASSOCIATION

BGA TECHNICAL COMMITTEE

TECHNICAL NEWSHEET TNS 3/4/92

- PART 1 Airworthiness "AGGRO" Please add to the 1992 BGA Red Pages. (Compendium of Airworthiness Directives, Mandatory Modifications and Special Inspections).

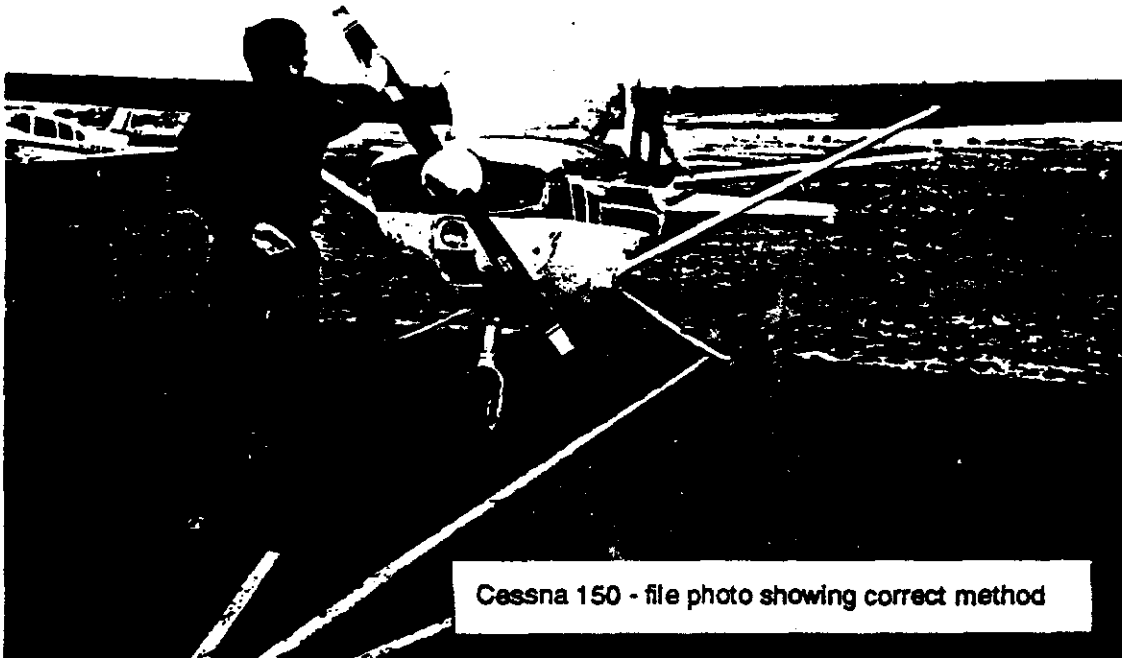
9. HAND SWINGING PROPELLERS

Cessna 150 - file photo showing correct method

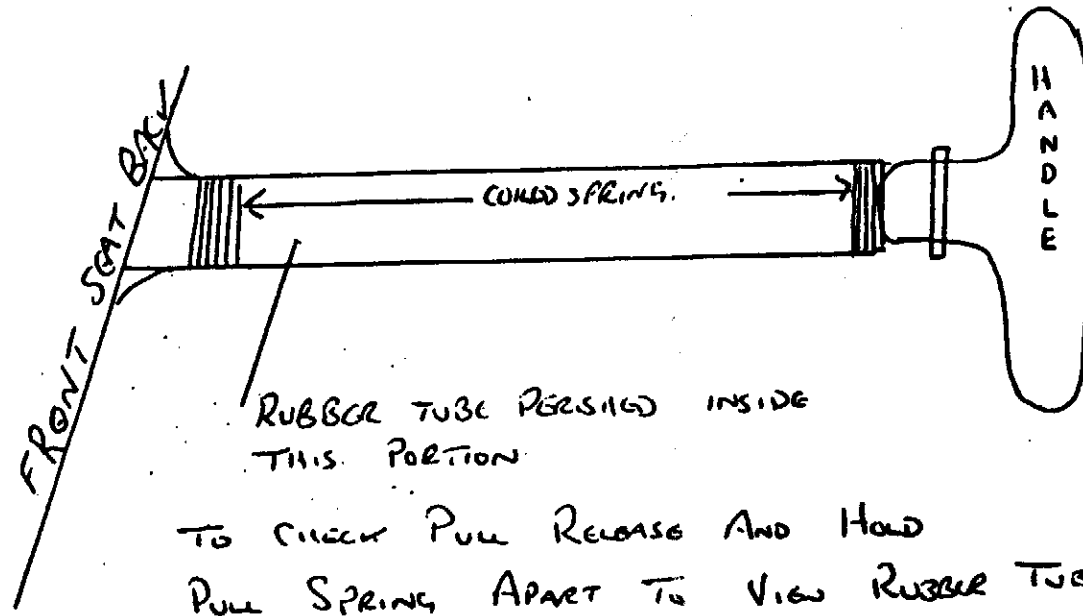
Pinchitz - Pull Release

- 1.9. ASH 25 - Aerotow Hook Facility. Tech Note 5 from UK Agents introduces this option.
 - 1.10. SZD-50-3 Puchatcz - Rear Tow Release jammed by perished rubber sleeve. Sketch by Harry Worth, Peterborough & Spalding G.C.
