BRITISH GLIDING ASSOCIATION

BGA TECHNICAL COMMITTEE

TECHNICAL NEWSHEET TNS 2/4/93

- PART 1** Airworthiness "AGGRO". Please add to the 1993 Blue Pages.
- 1.1. LAK 12 Aft Hook Installation. The factory supplied aft hook modification includes a "look-a-like" Tost type hook, which may fail to release under all backward-release situations. Replace with genuine Tost or otherwise rectify. (Seen at Badger Engineering, Hus. Bos.).

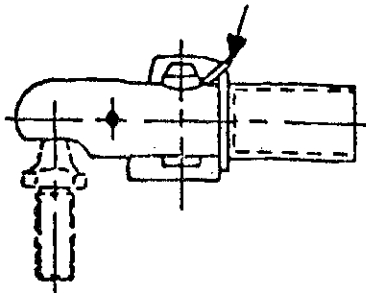
- a) Uerlings sleeve (no figure)
- b) safety pin (see figure 2 and 2a)
- c) LS safety sleeve (see figure 3)

- 1) If the joints are not yet equipped with safety pins (e.g. 1'H 140-31 made by Hotellier), these safety pins have to be retrofitted. In certain cases it may become necessary to rebores the hole in the lock plate, which is provided for visual inspection, to $\varnothing 1.2$ mm so that the safety pin can be inserted (see figure 1).

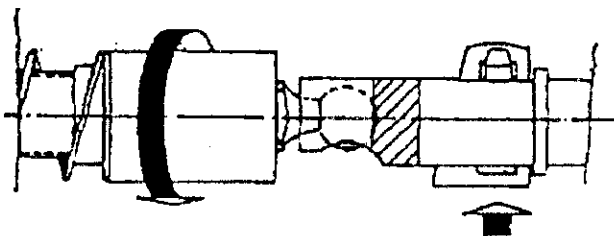
figure 3

Uerlings sleeves (specification number SE-00I/78) as well as LS safety sleeves can only be installed for straight joints and transmissions, but cannot be used for 90° joints.

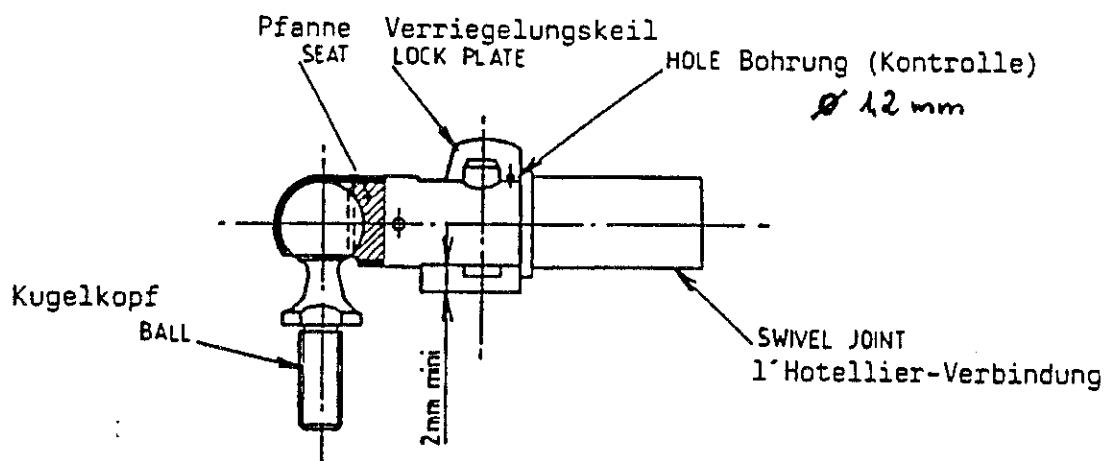
The swivel is to be slid completely over the ball with the lock plate pressed down. During locking the lock plate moves back slightly so that in a correct joint the hole on the narrow edge of the lock plate becomes visible.

The safety pin is to be inserted in this hole thus securing the ball and swivel joint.

Unsecured ball and swivel joints may open automatically in flight.

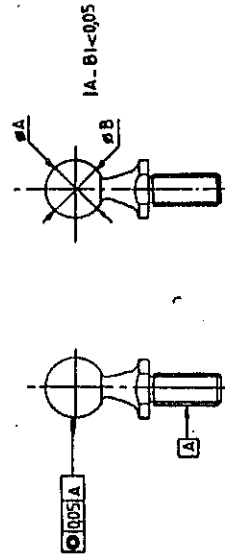
FIG.2

2-2 Determine ball sphericity (See Fig. 2)
