BRITISH GLIDING ASSOCIATION

BGA TECHNICAL COMMITTEE

TECHNICAL NEWSHEET TNS 9/10/93

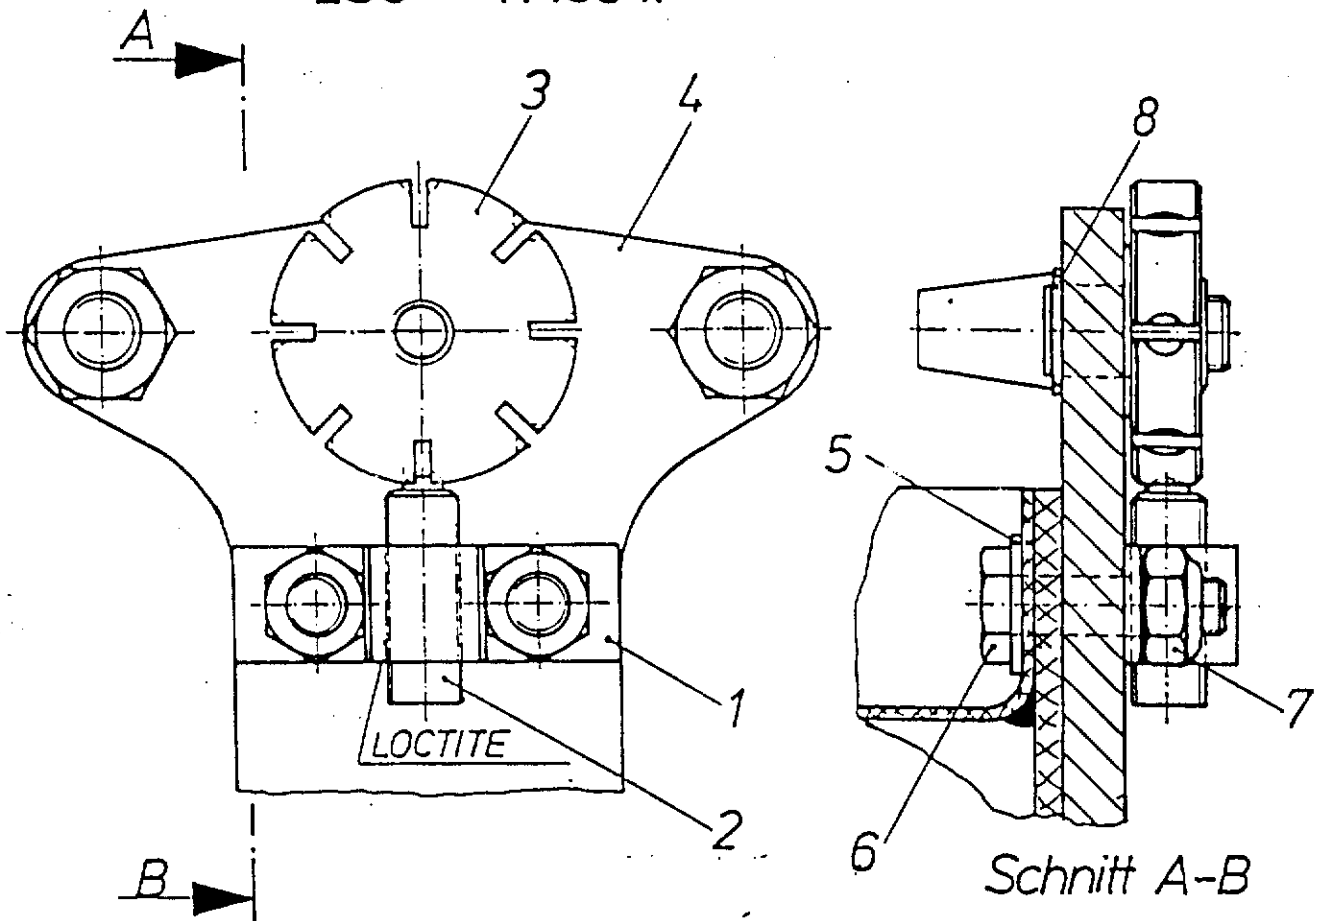
Datum	Name	Rolladen-Schneider Flugzeugbau GmbH	Maßstab: 1:1	
Gez.	9.3.93	U.	Benennung: Höhenleitwerkssicherung	Zeichn.-Nr. 4BR-164	
Bes.	1.7.93	Gesch.			
Gepr.	2. JULI 1993	Stempel			
Oberflächensch.: ✓			Kompl vor:	BZ-Nr.	
Rißprüfung: ✓				BZ-Nr.	
Pos.	Stck.	Benennung	DIN/LN	Werkstoff	Zeichn.-Nr.
