BRITISH GLIDING ASSOCIATION

TECHNICAL NEWSHEET TNS 1/2/94

PART 1 Airworthiness "AGGRO". Herewith the BGA 1994 Compendium of Airworthiness Directives, Mandatory Modifications and check list of Special Inspection and Defects.

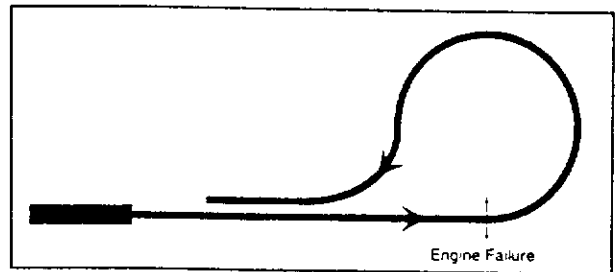
The analysis assumes a straight climbout followed by a 270-degree turn, a reversed 90-degree turn and a straight return to the runway. It also assumed that the climb starts at the end of the runway at 50 ft and at the specified climb speed. Flap extension for landing was not considered.

Results	Failure at 500 ft	Failure at 1000 ft
Time to climb	39 secs	84 secs
Distance covered	4937 ft	10,634 ft
Radius of turn	648 ft	648 ft
Return distance covered during turns	1296 ft	1296 ft
Distance remaining to runway	3641 ft	9338 ft
Total distance from failure back to runway	7711 ft	13,408 ft
Glide capability after engine failure	4560 ft	9120 ft

The analysis shows that from 500 ft a turn back would result in a landing 3150 ft short of the runway, and from 1000 ft the landing would be 4300 ft short.

In summary, for a single-engine aircraft, given reasonable wind conditions, it is not possible to return to the takeoff runway following an engine failure. Straight ahead and into wind is the only option. △
