BGA TECHNICAL COMMITTEE

TECHNICAL NEWSHEET (TNS) 11/12/94

PART 1 AIRWORTHINESS "AGGRO"

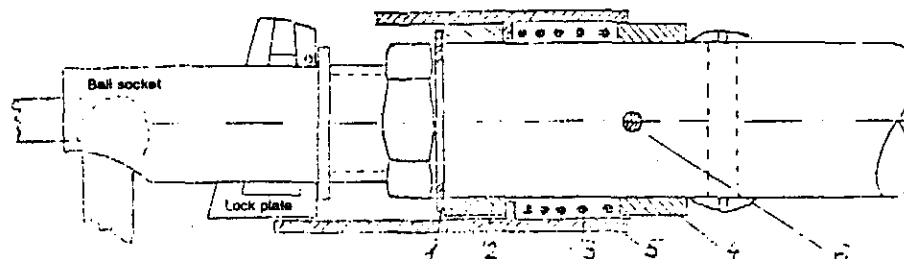
Scheme (Scale 2:1):

The automatic WEDEKIND-SICHERUNG is an alternative to the methods mentioned in the German LTA (AD) 93-001 for securing L'Hottellier quick locks.

The securing tube (item 5) can only be engaged, if the L'Hottellier quick lock is correctly installed. In this condition the securing tube covers the lower part of the lock plate and secures the lock plate against unintentional opening. Thereby the securing tube is fixed in the "secured position" by a pressure spring (spiral spring, item 3) with a spring tension of approx. 1.5 N.

- to prevent an unintentional moving of the bushing (item 2), it is recommended to fix the bushing using PATTEX or something similar prior to drilling.
- for a correct securing it is sufficient, if the securing tube (item 5) overlaps the lower part of the L'Hottellier lock plate for 3 mm
- if the overlapping is more than 3 mm, the front part of the securing tube can be grind accordingly

- The visible part of the secured bushing (item 4) has to be painted green. If after connection of the L'Hottellier quick locks the complete "green ring width" of approx. 4 mm is not visible (e.g. only 1 to 2 mm), the securing tube (item 5) does not cover the lower part of the locking plate - therefore the L'Hottellier quick lock is not secured. The reason for this (e.g. failed spiral spring (item 3)) must be rectified prior to the next flight.
- install control rods into sailplane
- check control deflections of ailerons, airbrakes and rudder, if necessary adjust according to Flight and Manual

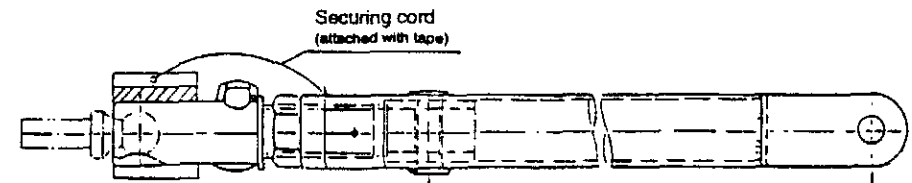
WARNING

Pay attention for the correct locking of the quick release attachment, i.e. the hole in the lock plate must be visible!

The securing sockets S26 have to be installed as follows:

- the securing sockets can be installed without removal and disassembly of the control rods
- push securing socket onto the quick release attachment and attach it to the rod using a cord
- for installation (or removal) during rigging (or de-rigging) the socket has to be turned as far as the mounting opening of the ball is free
- after installation the socket has to be turned as far as the mounting opening is completely closed
- the securing sockets S26 have to be checked for a sufficient jam efficiency or have to be exchanged during each annual inspection. Until revision of the relevant Maintenance Manuals, this inspection item has to be included hand-written.
