## BGA TECHNICAL COMMITTEE

### TECHNICAL NEWSHEET 3/4/96

K 8  
Technical Note  
No. 24

Subject : Glass fiber laminate covering the spar stub fittings

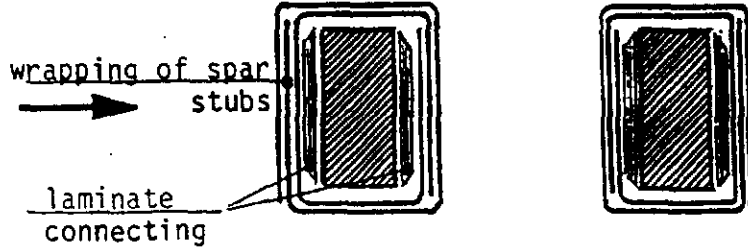
Fork stubs

Reason : Separation of laminate from wing attachment fittings allowing the ingress of moisture which in turn may lead to corrosion

Actions : 1. Inspection for a separation of the laminate at each annual inspection.  
A separation of the laminate is recognized by gaps showing at the face of the spar stub(s).  
If gaps are found, the fitting must be checked for corrosion by carefully lifting the laminate.  
If the fitting is free from corrosion, the laminate must be rebanded to the fitting as follows:  
Place wing leading edge down on trestles. Using thin wooden wedges force the gap to open and, with the aid of a syringe (internal diameter of needle to be 0.8 mm), carefully inject thickened resin into the cavity (Scheufler resin No. 285, mixed 100 : 38 with hardener No. 285 and "Aerosil" added).  
Next remove wedges and, using two clamps, two 8 mm hard core foam plates and two 16 mm wooden boards, press laminate against fitting and remove excessive resin. After curing and heat treatment (for 12 hours at 54° C) sand spar stub face and apply UP gelcoat (Schwabbellack).
