BGA TECHNICAL COMMITTEE

TECHNICAL NEWSHEET 1/2/97

PART 1 Airworthiness "AGGRO"

Technical Note
No. 301/18
No. 323/9
No. 826/34

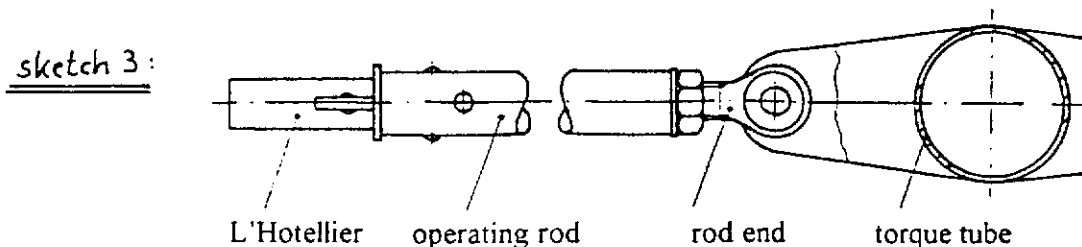
7. Screw together airbrake plate and outboard bellcrank using new self locking nuts M6 DIN 985-8 zn.
8. Now finally check if the airbrakes retract simultaneously. To measure retract the airbrakes so far, that the first cap is flush with the wing surface at the outboard end. Hold the airbrake handle in this position and measure how high the outboard end of the other airbrake is above the wing surface. Allowance 2mm (0.078in).

9. Also check handle forces to unlock the airbrakes (min.15daN, max.20daN resp. min.33lbs, max.44lbs). If handle force is below allowance elongate the operating rod of the airbrake retracting last by adjusting the rod end (s. sketch 3 below). If handle force is above allowance shorten the operating rod of the airbrake retracting first by adjusting the rod end. When adjustment of the airbrakes is finished don't forget to safety rod ends again by tightening the counter nut.

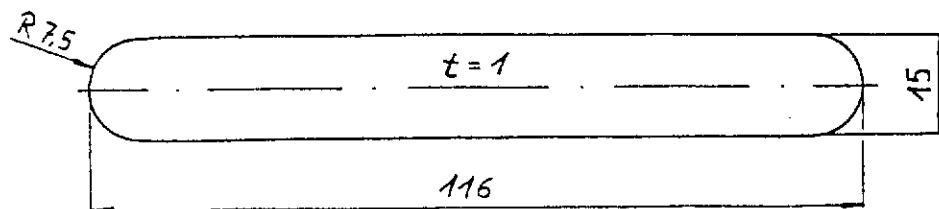
Prior to the next flight the airbrake torque tube in the fuselage must be inspected. Check the welded joint to the operating lever on cracks or deformation when locking and unlocking the airbrakes on the rigged airplane. The airbrake torque tube can be reached through the inspection hole in the fuselage. For inspection of the welding joint use a mirror and a magnifying glass (magnification min. 5x). In case of doubt remove torque tube for closer inspection.

If the torque tube is damaged by deep cracks and due to this corrosion inside the torque tube or the lever is suspected, the complete part 1St12 must be exchanged.

If necessary the welded joint of torque tube and operating lever must be reinforced by welding an additional steel sheet 1-St-12/2 made of material 1.7734.4 (s. sketch). Visible cracks or other defects of the original joint must be repaired first. All welding must be done with the TIG-welding system (tungsten inert gas) using welding wire 1.7734.2. Where welding is to be done cadmium plating or painting must be removed first by sandblasting.

After welding all metal surfaces must be protected against corrosion. This can be done by painting with suitable primer and paint.
