## BGA TECHNICAL COMMITTEE

### TECHNICAL NEWSHEET 5/6/98

#### PART 1     Airworthiness "AGGRO"

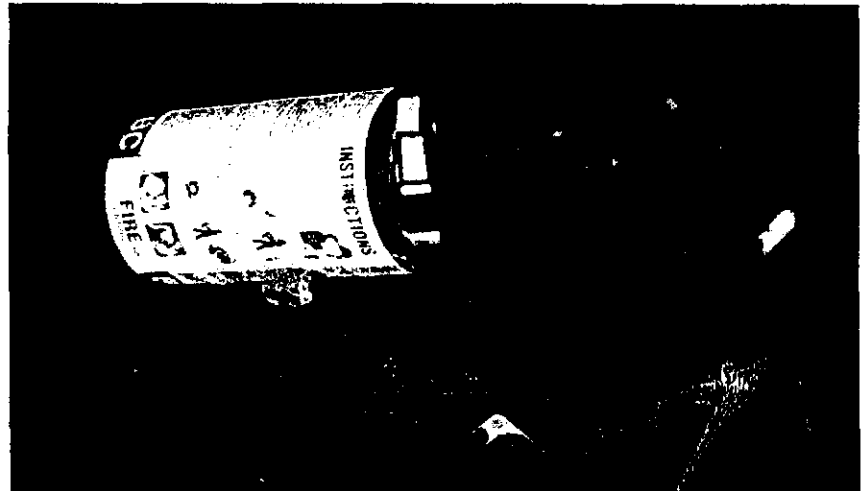
File photo

Aircraft type : Cessna 152  
 Date : December 1997

Another thought provoking letter from a reader describes an incident involving an engine fire while starting his Cessna 152 and makes the point that the Pilot's Operating Handbook (POH) contains no specific drill for engine fire on start up.

'Fortunately, due to an article I had read in an Aviation magazine, I had amended the POH by adding procedures for an engine fire during start as follows. *Fuel and magnetos 'off', throttle wide open and continue to motor engine.* This procedure draws ignited fuel in the induction system back into the cylinders to be evacuated through the exhaust ports.'
