BGA TECHNICAL COMMITTEE

TECHNICAL NEWSHEET 11/12/98

PART 1 Airworthiness "AGGRO"

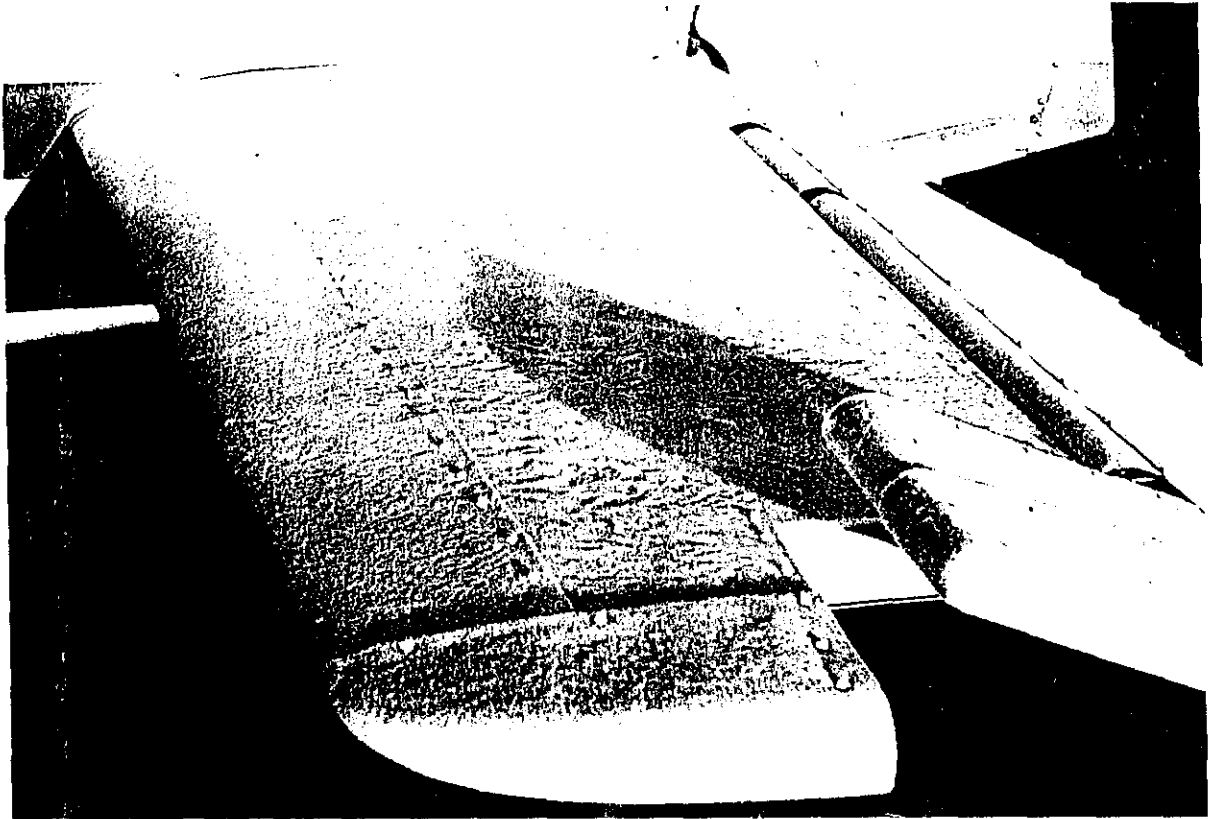
FROST ON WINGS

'A Cessna 172k struck trees and crashed about one minute after taking off from Broxborough, Massachusetts airport at about 0900. The pilot was killed. A witness saw the nose 'bobbing up and down' before the airplane descended out of view. The report said that there was frost on airplanes parked outside. 'There were no holes in the snow' from a ladder or 'footprints in the snow' where the airplane was parked. 'There was no evidence that any anti-icing fluid had been

applied to the top surface of the wings'.

found half an inch of ice coating the top of the wings.

These two items perfectly illustrate the need to **remove all ice, frost and snow from an aircraft** before flying. Even seemingly harmless frost can prove deadly as the 'roughness' destroys the smooth flow of air. Further advice is given in Safety Sense Leaflet No.3B "Winter Flying".
