BGA TECHNICAL COMMITTEE

TECHNICAL NEWSHEET 3/4/99

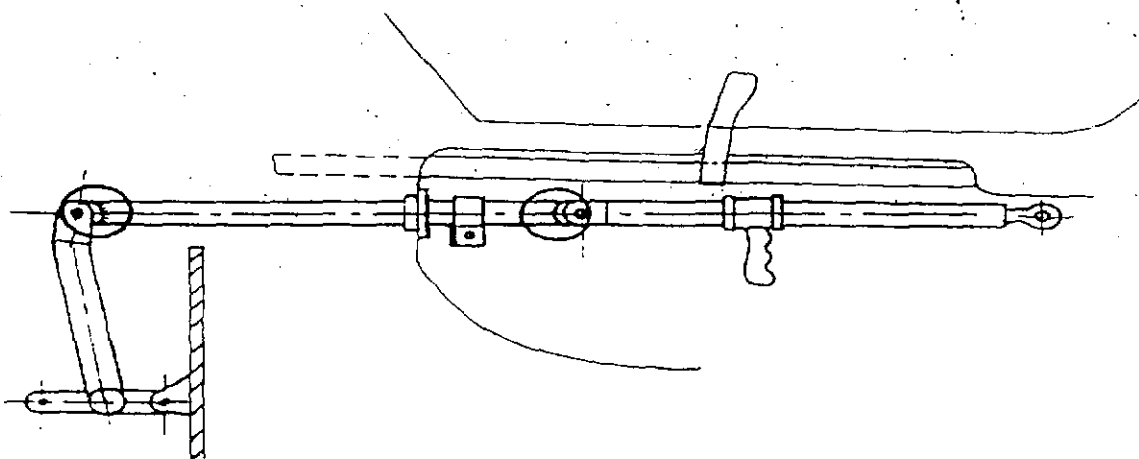
Le paragraphe VI de la section II du manuel d'entretien définit les procédures d'inspection des timoneries de commande de vol. Il précise entre autre qu'un examen de l'ensemble des commandes doit être effectué lors de chaque visite annuelle ou grande visite.

Nous tenons à attirer l'attention des utilisateurs sur l'importance de ces inspections et notamment sur la chaîne de commande des aérofreins dans le fuselage laquelle est particulièrement sollicitée.

En cas de constatation de crique, prendre contact avec S.N. CENTRAIR pour l'informer du défaut constaté. Une réparation du planeur doit alors être réalisée avant tout nouveau vol.
