British Gliding Association – Technical Committee

Technical News Sheet 11/12/00

British Gliding Association
Aircraft Inspection

Number:
011/12/2000

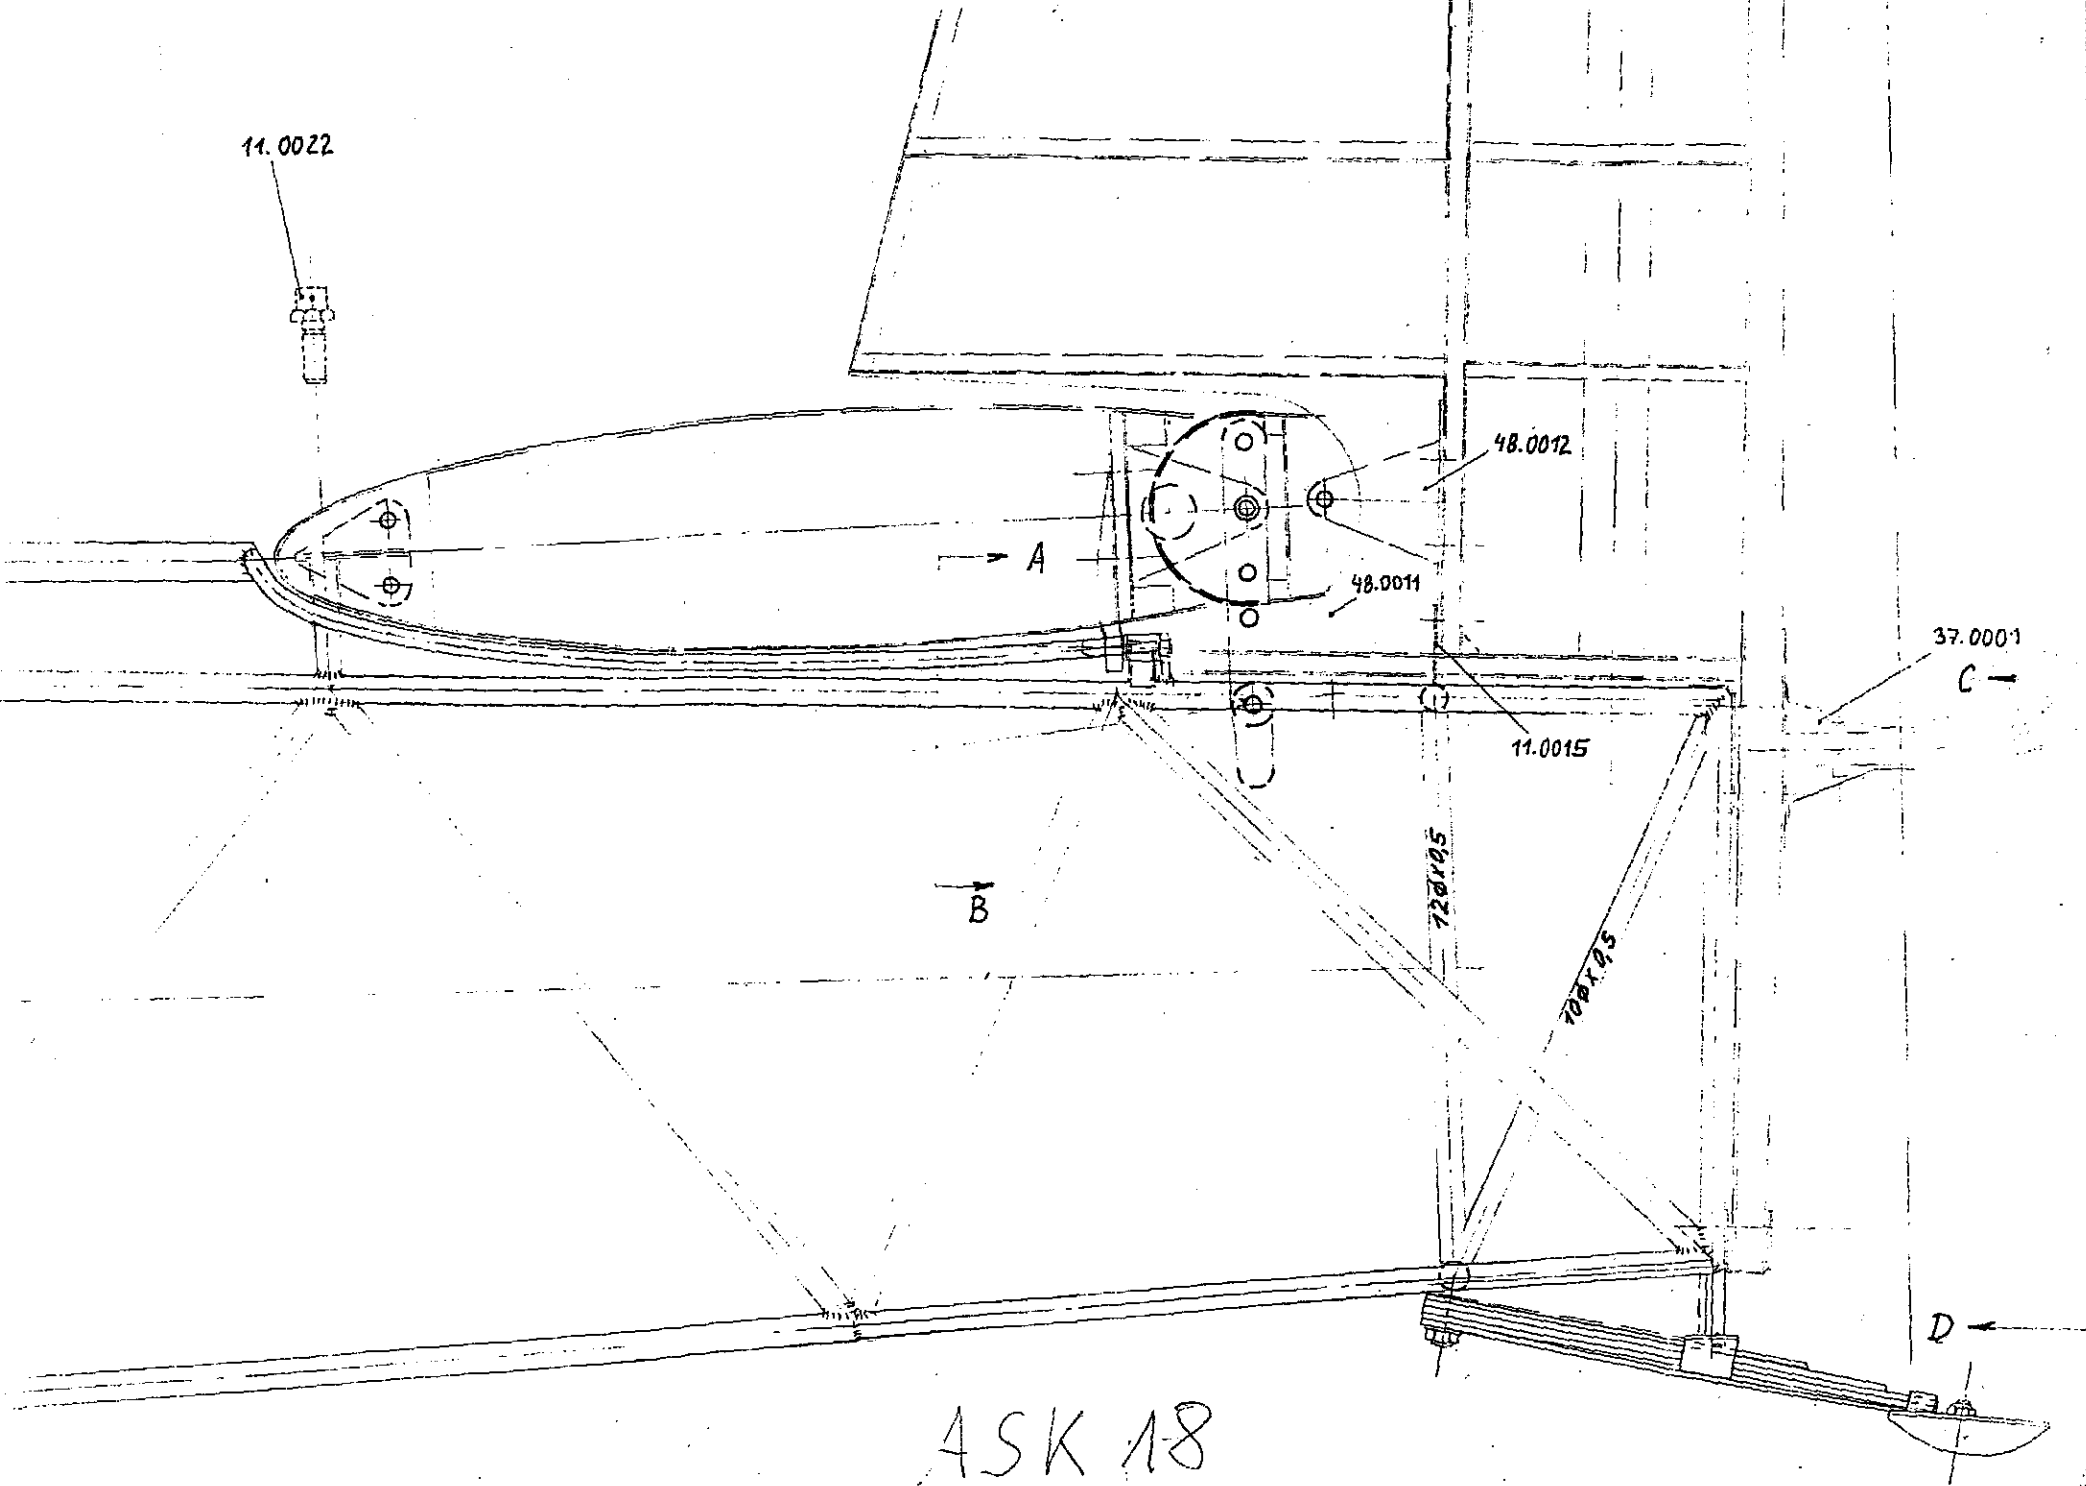
ASK 18

Possible sources of mistakes in the automatically elevator connection
of the types Schleicher Ka 2 and Ka 2B, Ka 6, K 7 and K 8. (US 7G1, 7G3, 7G4)

This point should be given special attent at the inspections.
