BGA ENGINEERING

NEWS

Number 6, May 2001

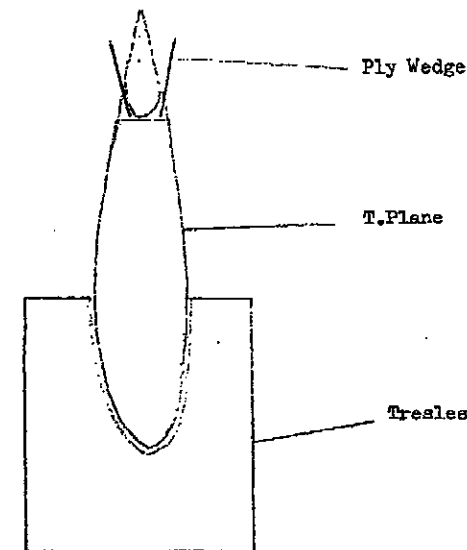
FIG 5 Positioning of Elevators

- (i) The elevators should now be repositioned to ensure the rib is still located in the correct position. The elevators should be pushed fully home again ensuring the split pin hole is accessible. Position wedges as shown in Fig 5 to hold the elevators in the neutral position.

(e)	Coat the rib with glassflock and initially position the rib to the dimensions detailed in Fig 4.	
(f)	Position the tailplane in trestles as shown in Fig 5.	
ISSUED BY:	<i>B. Miller</i>	Date 14th Sept 82
for and on behalf of	SLINGSBY ENGINEERING LIMITED Kirkbymoorside, York YO6 6EZ, England. Tel. 0751 31751 Telex 57911	Page 2 of 7
