# BGA ENGINEERING NEWS

Number 8, September 2001

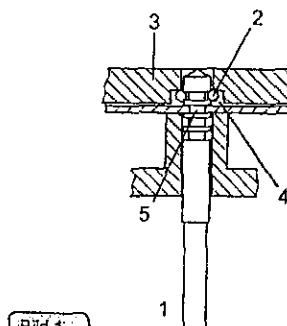
Bild 1

- Damping of jet needle (1) against vibration by additional O-ring (2) 2,5x1,5 (see fig. 1).

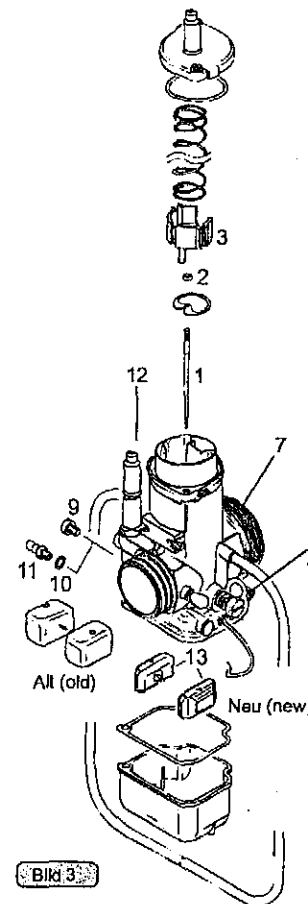
Bild 3

- The suction side carburetor flange (7) is furnished with a thread groove to increase the hold of the intake system (airfilter, intake silencer etc.). See fig. 3.
- The idle air regulating screw (8) is provided with a hexagon head (wrench 13 mm) instead of knurled head. See fig. 3.

- All new carburetors have a depression connection for the high altitude kit (HAC kit). See fig. 3.
