**BRITISH
GLIDING
ASSOCIATION**

Technical News Sheet

Issue 2-2015

Date: 12/06/2015

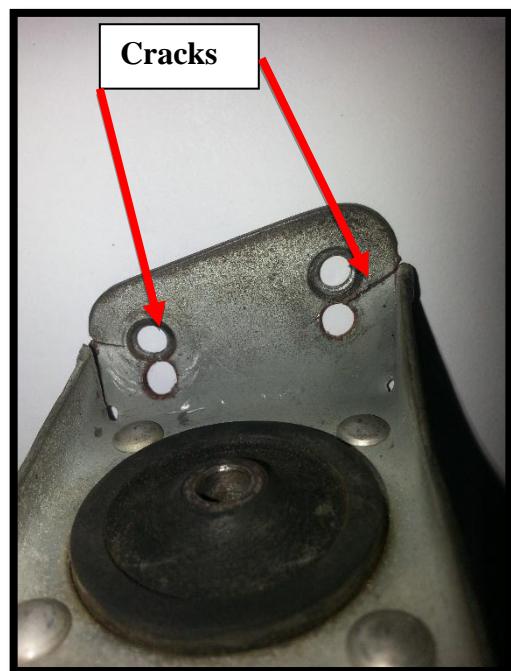
9

This bracket supports the instrument panel and the cable release. The fractures/splits in the brackets could potentially result in the bracket coming completely apart resulting in the pilot having the panel in his or her lap. More importantly, the pilot may not be able to release the cable under pressure. Also ensure the rubber is not perished. This particular example appears to have been modified with non-standard extra holes.

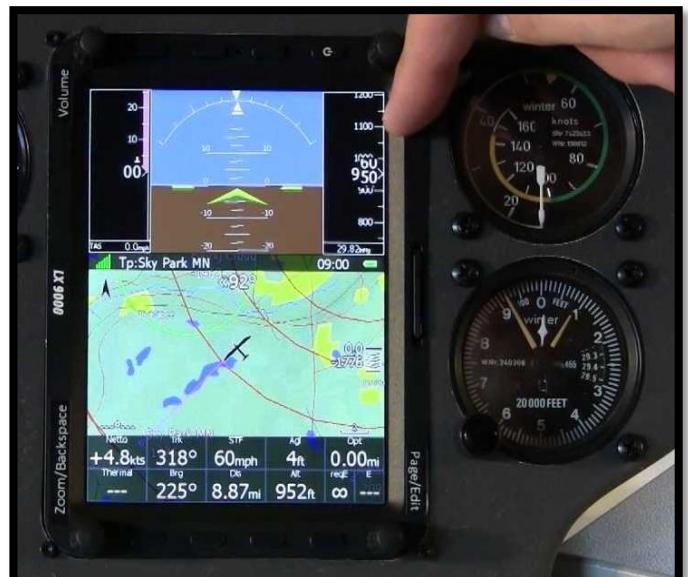
17 Primary Flight Displays and Electronic Supplemental ASI**Advisory**

There are many very nice uncertified Primary Flight Display instruments (Dynon and LX9000 are just two of them) now on the market.

More and more pilots are relying on the uncertified electronic ASI in flight, so it is recommended to calibrate them at annual, even though not legally required.

However If there is a significant leak in any of the plumbing it can make the primary ASI misread as well.

Put the manometer onto the pitot line that feeds both the ASIs, at the same time while calibrating and performing a leak check.
