Glider Type and Registration (Tail No):	Discus CS	Lak 17
BGA No:	G-IDER (W4)	G-CKOI (170)
Engine:	None	1 (turbo)
Year of Manufacture:	1992	2006
Time (local) and Date:	16:02 hrs on 26 July 2014	
Location:	Lt. Paxton, Nr. St. Neots, Cambs.	
Type of flight (actual/intended):	Competition task (both gliders)	
Type of launch:	Aerotow	Aerotow
Persons on Board:	1	1
Nature of Damage:	Glider destroyed	Serious
Injuries:	Minor	Minor
P1's Qualifications:	Silver C	3 diamonds
P2's Qualifications:	N/A	N/A
Commander's Age:	70 years	60 years
Commanders' Flying Experience :		
Total all types:	800 hrs	5000 hrs
Total on Type:	200 hrs	1000 hrs
Last 6 months:	15 hrs	100 hrs
Information Source(s):	BGA Accident Report Forms, Club Investigation, witness statements and follow-up enquiries

Synopsis

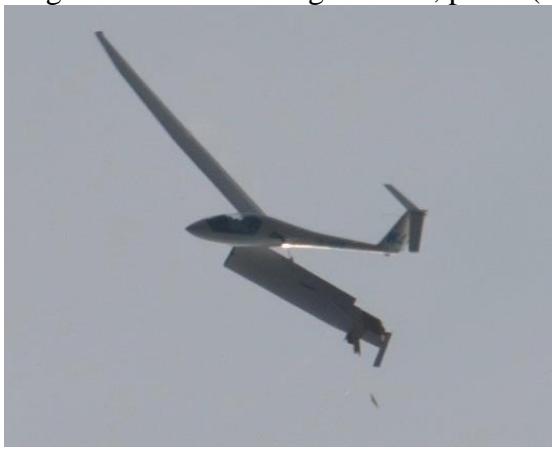
(a)

The pilot had seen another glider flying in the same area as his on several occasions while on the competition task. He thought he saw a glider prior to the accident circling in what seemed to be a poor thermal about half a mile away. He didn't recollect seeing any more of this glider until immediately before the impact, when it appeared from his left side and above, impacting with W4's raised left wing. As it did so, there was a very loud noise and the glider went into a tumbling spin, photo (a). The pilot realised that he had no option but to get out, so operated the normal canopy-opening knob and thought that the canopy flew off¹. He then pulled the seat harness release lever and with no effort he fell from the glider into a tumbling free fall, photo (b)
