Glider Type and Registration (Tail No):	Hoffman H36 Dimona G-BLCV
Engine:	1 x Limbach L2000 – EBIC piston engine
Year of Manufacture:	1984
Time (local) and Date:	15:00 hrs 5 April 2016
Location:	2NM North of Raglan, Monmouthshire
Type of flight (actual/intended):	Training (field selection exercise for Bronze Cross-Country endorsement)
Persons on Board:	2
Injuries:	Instructor: Broken collar bone Student: Hairline fracture in one vertebrae
Nature of Damage:	Severe damage, beyond economic repair
Commander's Qualifications:	Full Cat and MGIR
Commander's Age:	64 years
Commander's Flying Experience:	Total all types: Gliders – 1,793 hours Power - 503 hours Total on Type: 265 hours Last 6 months: Gliders – 6 hours Power - 10 hours
Information Source(s):	Information supplied by the pilot/student, examination of the wreckage and follow-up enquires

Synopsis

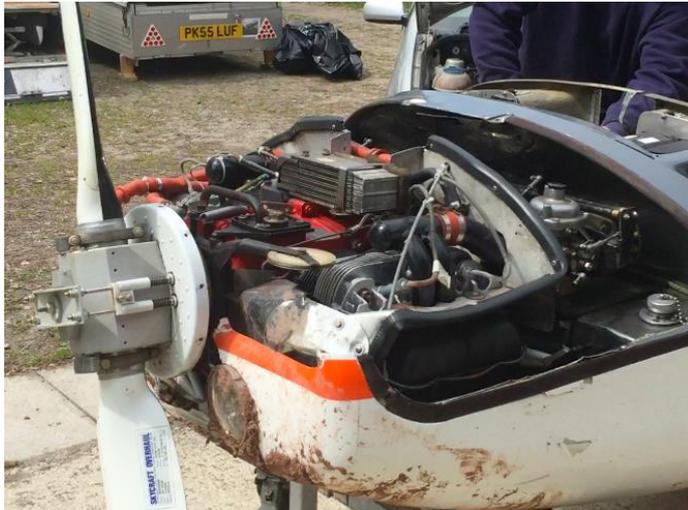
Photo 4

There was no evidence from the wreckage examination or from the pilot's report to suggest any and pre-impact problems had occurred with the aircraft, apart from the failure of the engine to respond. As the engine itself (and ancillary equipment) appeared undamaged and remained securely mounted to the airframe, the opportunity was taken to conduct a functional test by installing an identical time expired but serviceable propeller, see Photo 4.

After fitment, the engine was rotated by hand and it was established that all four compressions felt normal. After the drain valve leak had been sealed, fresh AVGAS 100LL placed in the tank, and a set of jump leads were connected to the battery. The master switch was moved to ON and, at this point, the carburetors were primed by the electric fuel pump, which functioned normally, and all engine instruments became 'live'
