ACCIDENT

Aircraft Type and Registration:	SZD-55-1, G-CKLR	
No & Type of Engines:	None	
Year of Manufacture:	1993 (Serial no: 551193056)	
Date & Time (UTC):	8 April 2017 at 1045 hrs	
Location:	Currock Hill Airfield, Northumbria	
Type of Flight:	Private	
Persons on Board:	Crew - 1	Passengers - None
Injuries:	Crew - 1 (Fatal)	Passengers - N/A
Nature of Damage:	Extensive	
Commander's Licence:	Private Pilot's Licence	
Commander's Age:	62	
Commander's Flying Experience:	18,800 hours (of which 39 were on type) Last 90 days - 1 hour Last 28 days - 0 hours	
Information Source:	AAIB Field Investigation

Synopsis

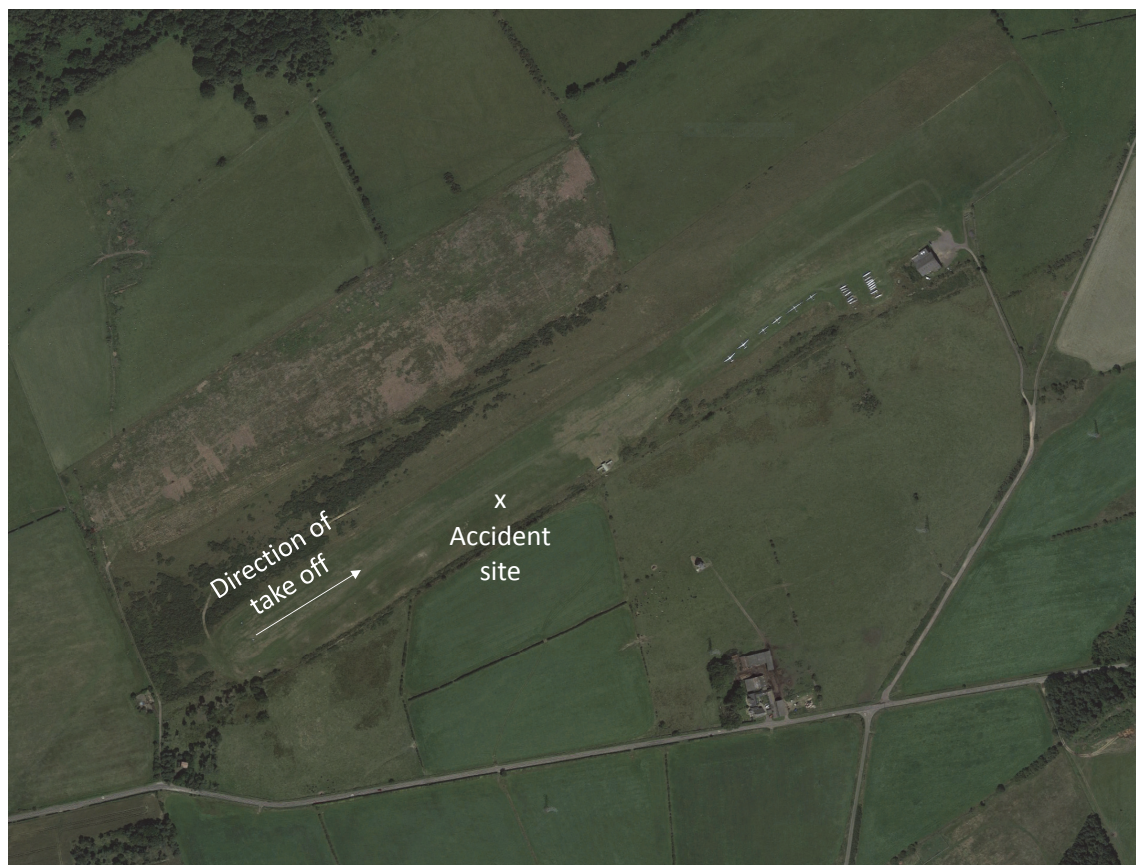
Figure 1

Currock Hill has a grass strip orientated 06/24 which is 600 m long. It is operated by a gliding club. The gliders are towed into the air using a light aircraft and a tow rope. The airfield and the accident site are shown in Figure 1.

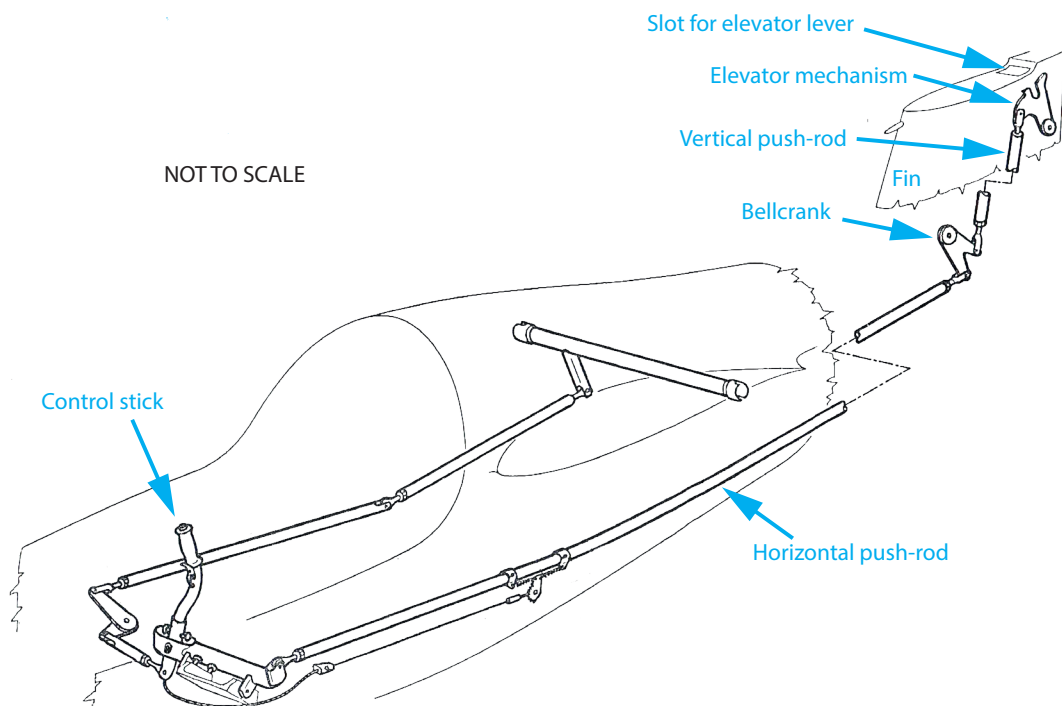
Figure 3
SZD-55-1 elevator control system

The elevator control system on the SZD-55-1 (Figure 3) comprises a horizontal push-rod which runs from the control stick quadrant, throughout the length of the fuselage to the base of the tail fin, where it is connected via a bellcrank to another push-rod, which runs vertically up through the fin. At the top of the vertical push-rod, a pivoting guide mechanism, known as the elevator mechanism, couples with the elevator control hinge (elevator lever), when the tailplane is attached to the fin. A roller on the end of the elevator lever facilitates alignment by ensuring the lever engages in the U-shaped channel of the mechanism. Figure 4 shows a detailed view of the elevator lever and elevator mechanism.

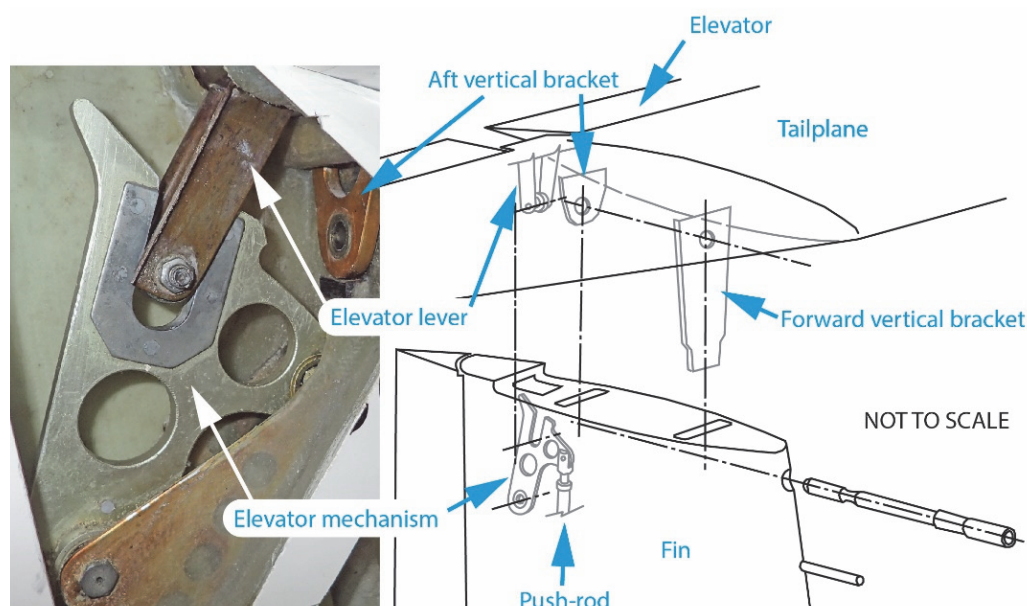
Figure 4

Normal connection of elevator lever and elevator mechanism on SZD-55-1

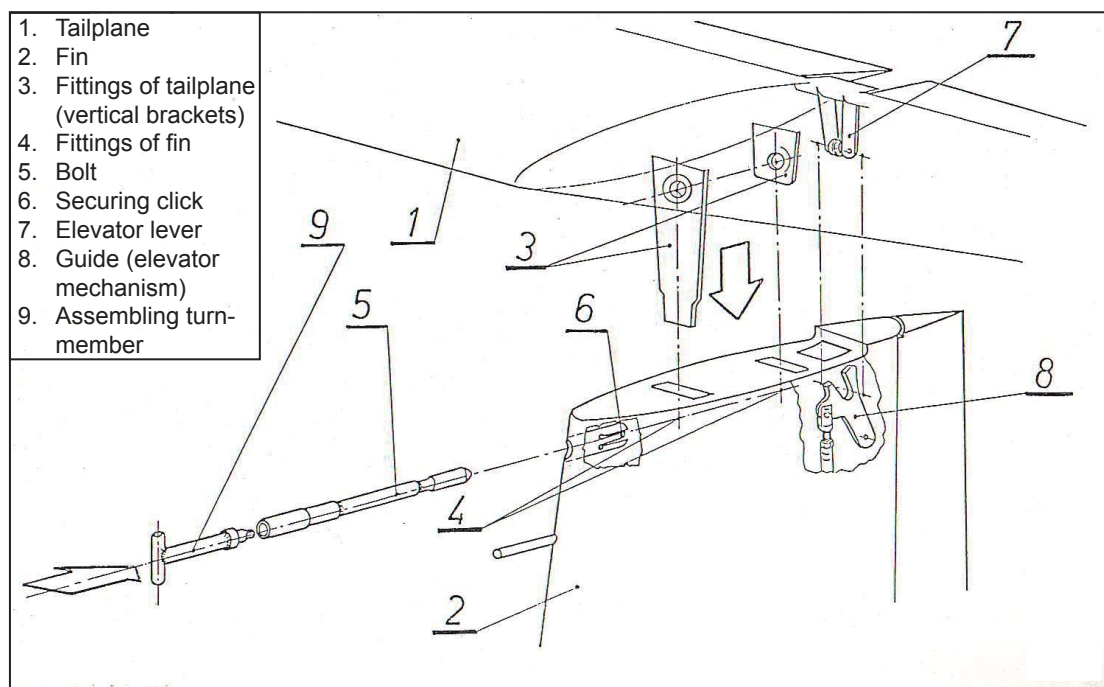
Figure 5

With respect to rigging the tailplane, the following instructions are given in the Flight Manual. The numbers in parenthesis refer to the items labelled in Figure 5:

- *Put the [control] stick in the neutral position using the trimming device.*
- *Fit the tailplane (1) on the fin. Move the stick, if necessary, to insert the lever (7) into the guide (8).*
- *Connect the tailplane (3) and fin (4) fittings by means of bolt (5) with the assembling turn-member (9) screwed in*
- *Screw-off the assembling turn-member and check at the final phase of screwing-off (2 threads) the efficient securing [of] the bolt against shifting out.*
- *.....*
- *Hold the elevator and ailerons and check the operation of the control systems under the loading.*
- *.....'*

Amended extract from SZD-55-1 Flight Manual
showing tailplane and elevator rigging
