**ACCIDENT**

<b>Aircraft Type and Registration:</b>	1) Cessna 152, G-WACG 2) Guimbal Cabri G2, G-JAMM
<b>No &amp; Type of Engines:</b>	1) 1 Lycoming O-235-L2C piston engine 2) 1 Lycoming O-360-J2A piston engine
<b>Year of Manufacture:</b>	1) 1982 (Serial no: 152-85536) 2) 2017 (Serial no: 1185)
<b>Date &amp; Time (UTC):</b>	17 November 2017 at 1201 hrs
<b>Location:</b>	Near Waddesdon, Buckinghamshire
<b>Type of Flight:</b>	1) Training 2) Training
<b>Persons on Board:</b>	1) Crew - 2                      Passengers - None 2) Crew - 2                      Passengers - None
<b>Injuries:</b>	1) Crew - 2 (Fatal)          Passengers - N/A 2) Crew - 2 (Fatal)          Passengers - N/A
<b>Nature of Damage:</b>	Both aircraft destroyed
<b>Commander's Licence:</b>	1) Commercial Pilot's Licence 2) Airline Transport Pilot's Licence (H)
<b>Commander's Age:</b>	1) 27 years 2) 74 years
<b>Commander's Flying Experience:</b>	1) 419 hours (of which around 400 were on type) Last 90 days - n/k hours Last 28 days - 19 hours  2) 25,000+ hours (of which n/k were on type) Last 90 days - n/k hours Last 28 days - n/k hours

<b>Information Source:</b>	AAIB Field Investigation

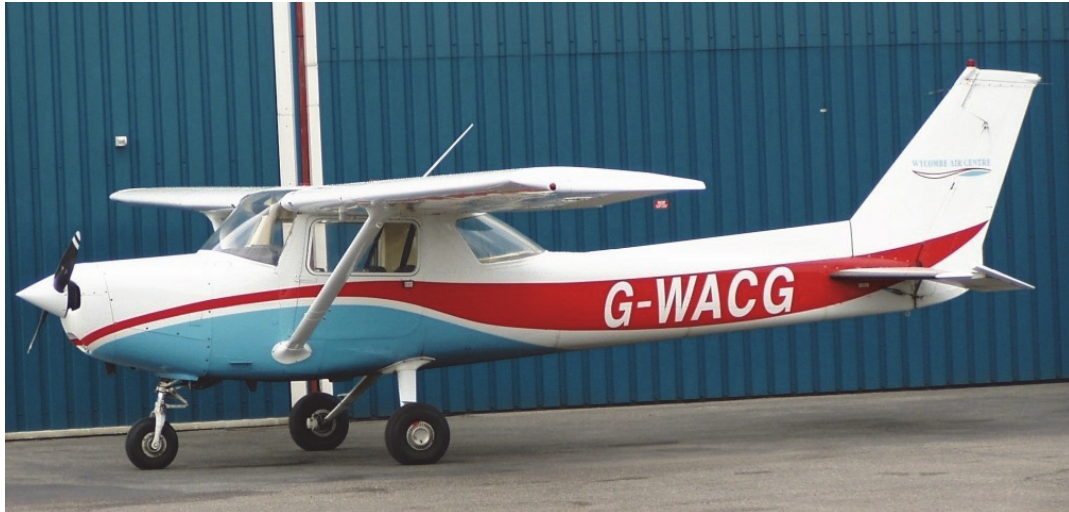
**Figure 7**

G-WACG was painted predominantly white with a light blue underbelly and a red stripe along the length of the fuselage side, Figure 7. It was fitted with red, green and white navigation lights, a red anti-collision beacon on the vertical fin and a landing light in the engine cowling beneath the propeller spinner.

G-WACG in the colour scheme when the accident occurred  
(Photograph used with permission)

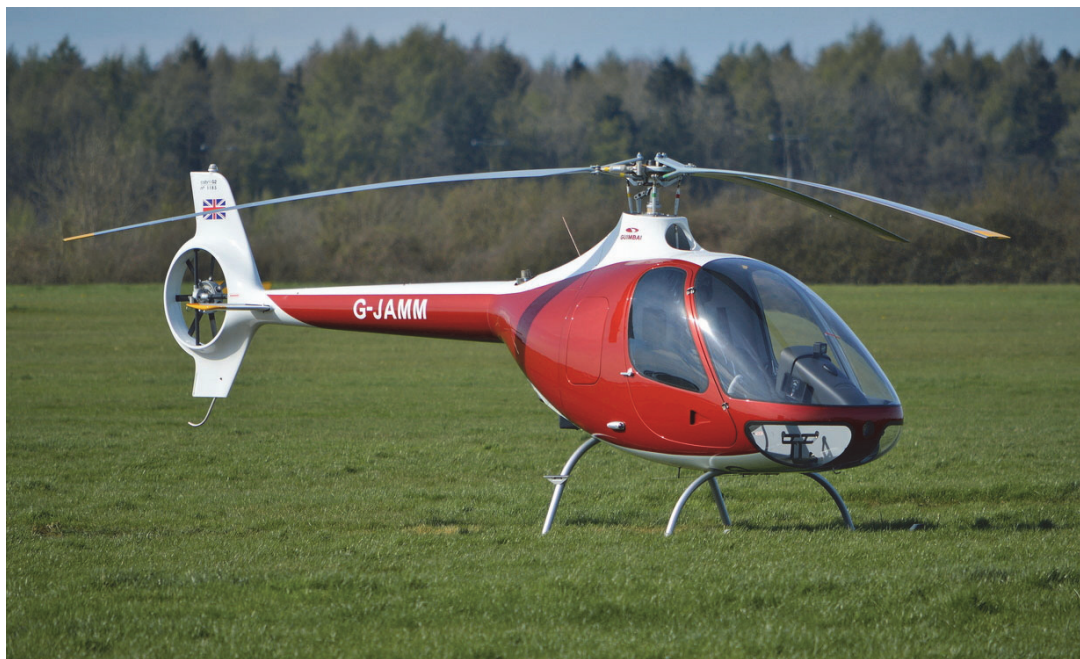
**Figure 8**

G-JAMM was painted predominantly metallic red with the upper and rearmost section of the tail boom being white (Figure 8). The main rotor blades were painted light grey with yellow tips.

G-JAMM in the colour scheme when the accident occurred  
(Photograph used with permission)

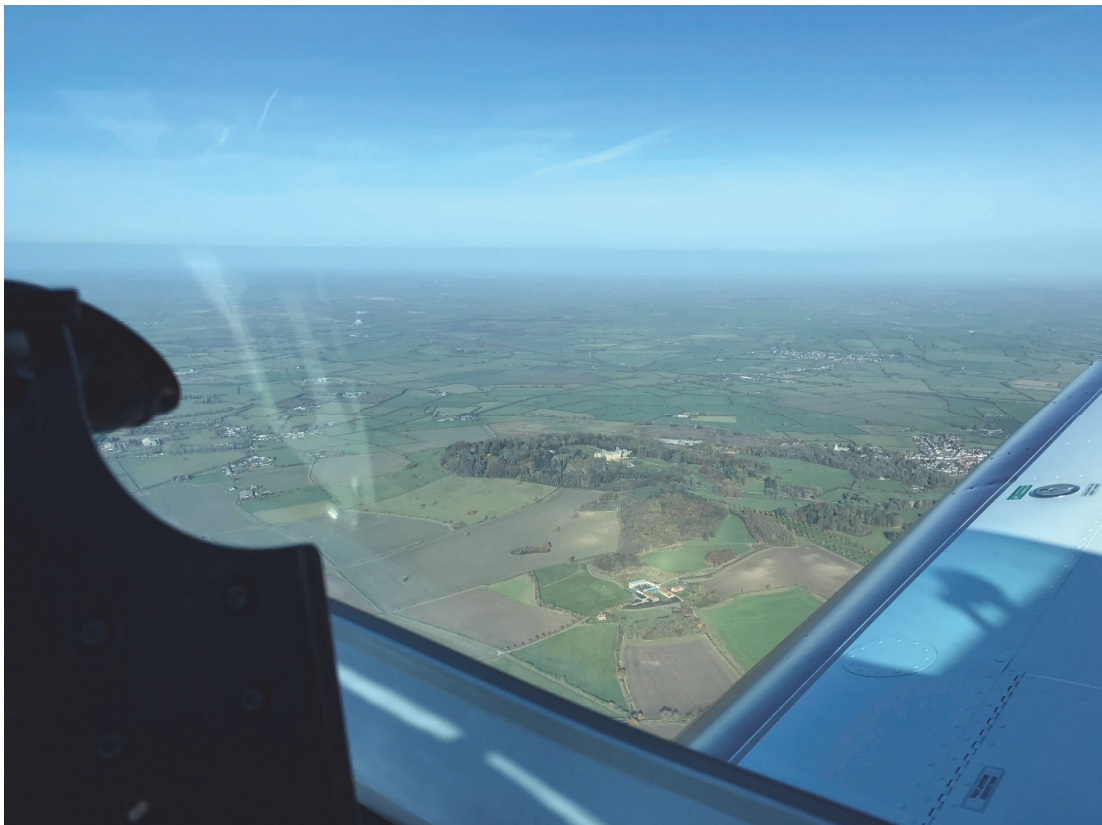
**Figure 9**

The weather conditions were clear with good visibility. A photograph of the inflight conditions taken by a pilot of another aircraft operating in the area ten minutes before the accident and travelling in the same direction as the accident aircraft is shown at Figure 9.

En route weather conditions at location of accident  
(Photograph used with permission)
