ACCIDENT

Aircraft Type and Registration:	Grob G109B, G-KHEH	
No & Type of Engines:	1 Grob 2500 E1 piston engine	
Year of Manufacture:	1986 (Serial no: 6436)	
Date & Time (UTC):	10 June 2018 at 0959 hrs	
Location:	Near Raglan, Monmouthshire	
Type of Flight:	Training	
Persons on Board:	Crew - 2	Passengers - None
Injuries:	Crew - 2 (Fatal)	Passengers - N/A
Nature of Damage:	Aircraft destroyed	
Commander's Licence:	Private Pilot's Licence	
Commander's Age:	68 years	
Commander's Flying Experience¹:	550 hours (of which 27 were on type) Last 90 days - 7 hours Last 28 days - 2 hours	
Information Source:	AAIB Field Investigation

Synopsis

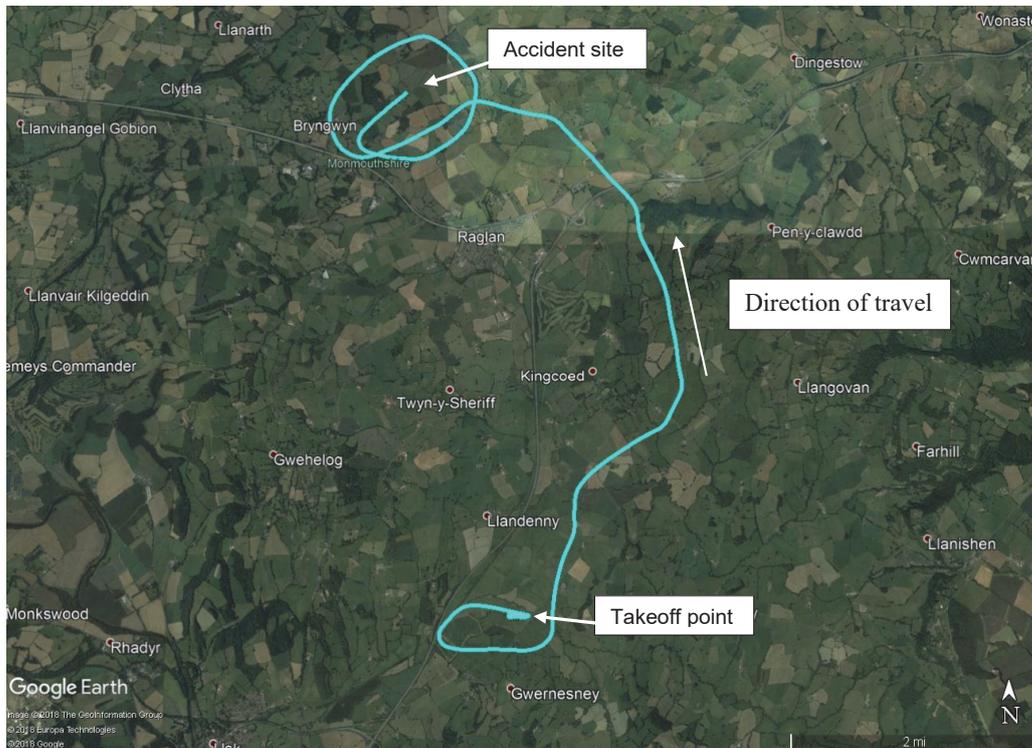
Figure 1

It is not known whether a brief took place or the details of the intended flight, but the TMG took off from Usk Airfield at about 0947 hrs with the instructor and student on board. Witnesses report seeing the aircraft shortly after this time near the town of Raglan, about 4 miles north of the airfield. Recovered flight data shows the aircraft flew an orbit over an area of fields approximately 1.5 miles to the north-west of the town, before commencing an apparent final approach for a practice force landing into a large field (Figure 1).

G-KHEH flight of 10 June 2018
