**ACCIDENT**

<b>Aircraft Type and Registration:</b>	Standard Cirrus 75, G-DDGX	
<b>No &amp; Type of Engines:</b>	No engines	
<b>Year of Manufacture:</b>	1975 (Serial no: 619)	
<b>Date &amp; Time (UTC):</b>	27 July 2019 at 1130 hrs	
<b>Location:</b>	Gwernesney Airfield, Monmouthshire	
<b>Type of Flight:</b>	Private	
<b>Persons on Board:</b>	Crew - 1	Passengers - None
<b>Injuries:</b>	Crew - 1 (Fatal)	Passengers - N/A
<b>Nature of Damage:</b>	Aircraft destroyed	
<b>Commander's Licence:</b>	British Gliding Association (BGA) Certificate with B Badge Endorsement	
<b>Commander's Age:</b>	54 years	
<b>Commander's Flying Experience:</b>	Total hours not determined 182 flights totalling 41 hours since August 2015 (of which 2 hours and 20 minutes were on type) Last 90 days - 3 hours and 42 minutes Last 28 days - 1 hour and 38 minutes	
<b>Information Source:</b>	AAIB Field Investigation

**Synopsis**

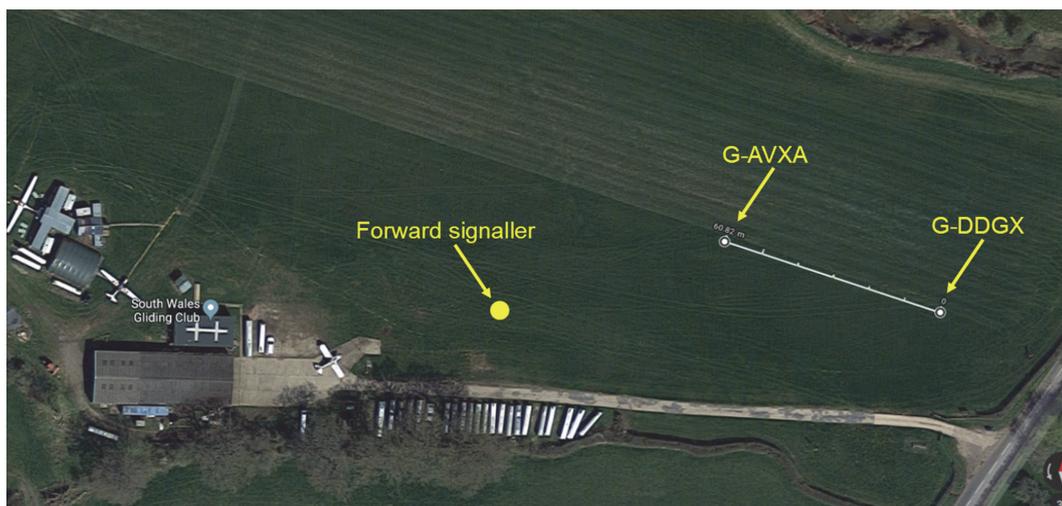
**Figure 1**

Approximate disposition of G-AVXA, G-DDGX and forward signaller before takeoff

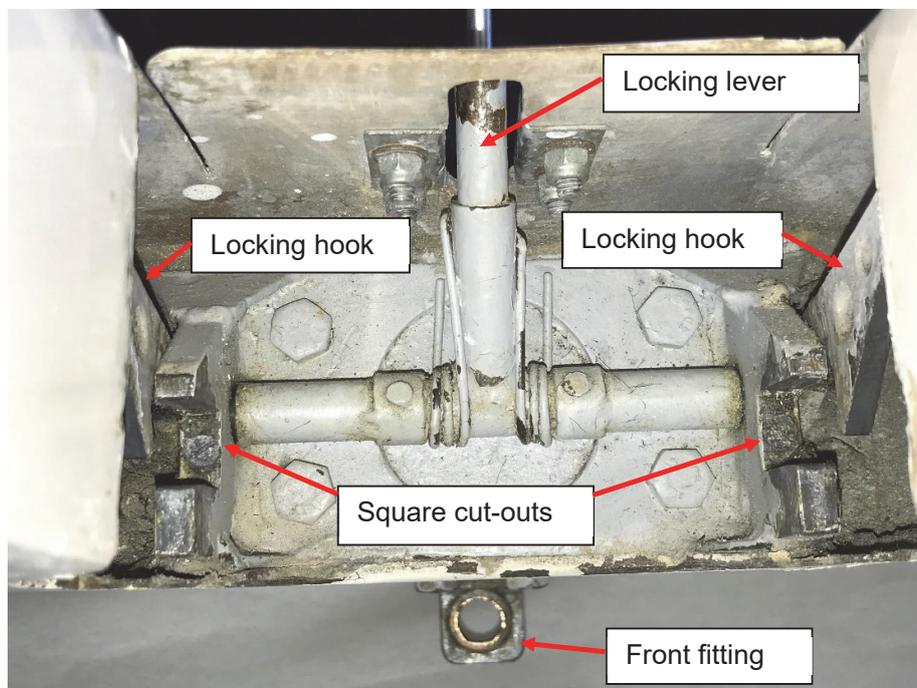
**Figure 5**

Standard Cirrus 75 Modified tailplane attachment mechanism  
(view looking forward)

When the tailplane is placed on top of the fin, square cut-outs in the mounting bracket engage with the square sections of the axle on the fin fitting, to locate the tailplane. Two adjustable setting screws on the square axle sections are used to remove any tangential play in the mechanism. The locking hooks engage with the circular ends of the axle. The hooks are spring-loaded to the closed position and are operated by a locking lever.

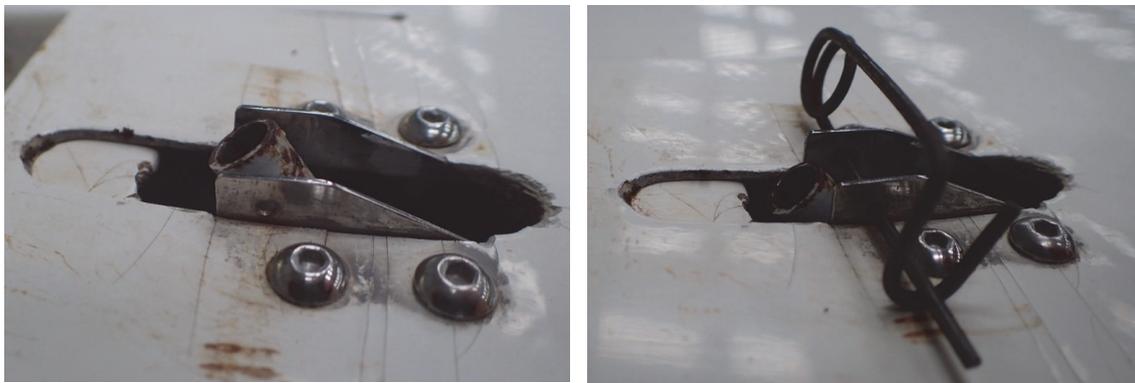
**Figure 6**

When the tailplane is attached, the locking lever protrudes through a slot in the top surface of the tailplane. The locking lever is hollow, and a rigging tool can be inserted for ease of movement. To lock the tailplane in place, the locking lever is moved to the aft end of the slot. A safety pin is then inserted forward of the locking lever to prevent it moving forward towards the unlocked position (Figure 6). To de-rig the tailplane the safety pin is removed, and the locking lever is moved forward to release the locking hooks from the axle.

Locking lever when tailplane attached (left image)  
and when locked with safety pin inserted (right image)

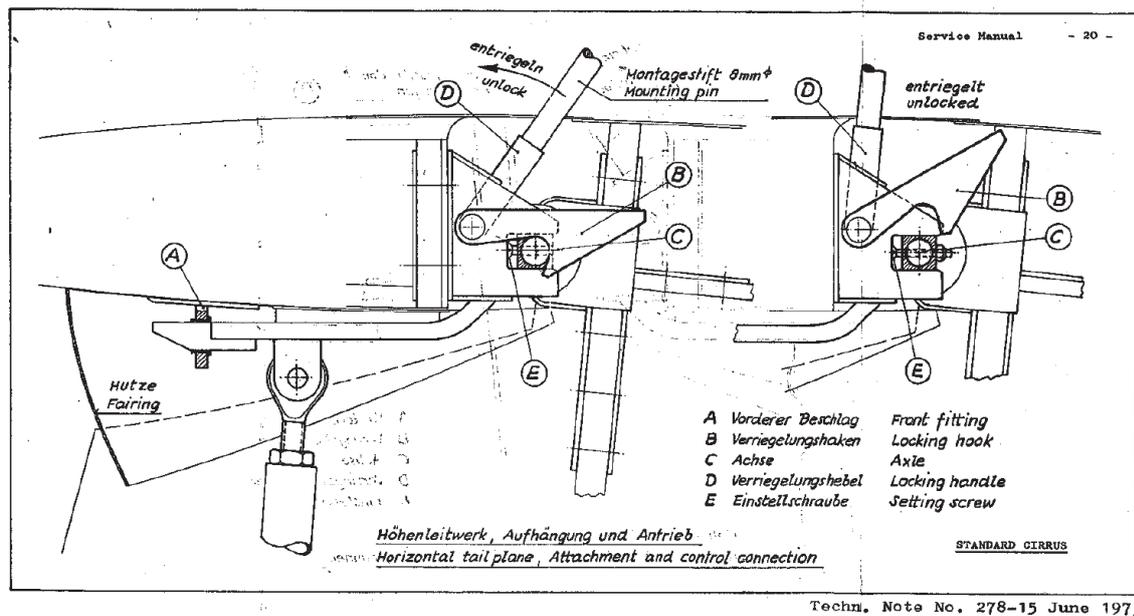
**Figure 7**

In 1975, the modified tailplane attachment mechanism was introduced by Technical Notice (TN) 278-15 '*Attachment and control connection of the horizontal tailplane*' (Figure 7). The reason for the modification was described as '*Simplification of the mounting, easy checking of the mounting, adjustable tangential backlash of the elevator control.*' Later models of the Standard Cirrus, including G-DDGX, were manufactured with TN 278-15 already embodied.

Tailplane attachment and control connection from TN 278-15 and Standard Cirrus flight manual

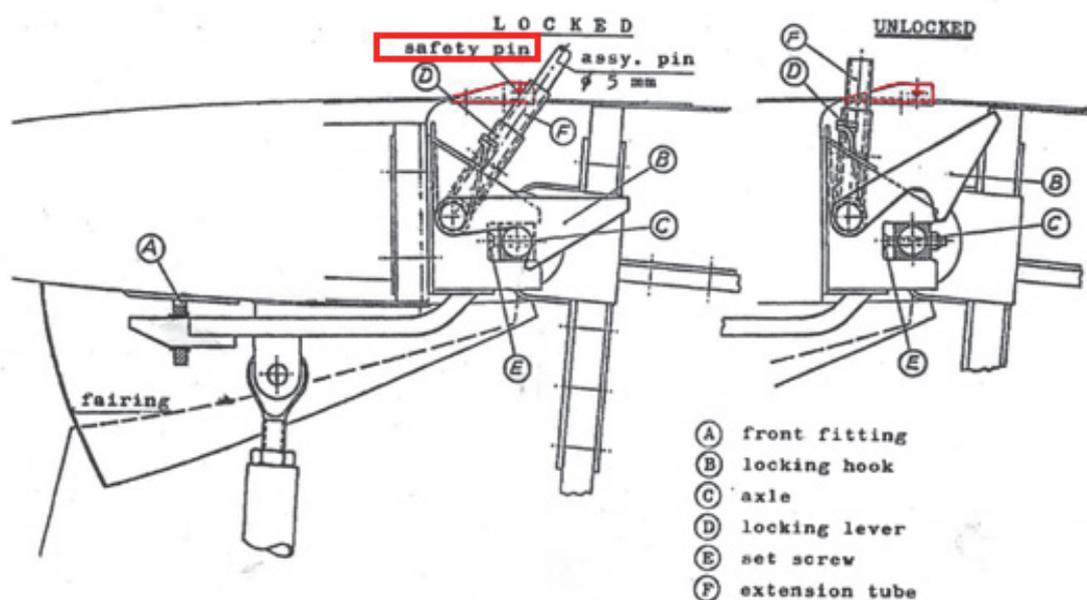
**Figure 8**

TN 278-36 'Safety device for the locking lever of the tailplane attachment,' was introduced on 24 November 1994 and was subsequently mandated by Airworthiness Directive 95-015<sup>6</sup> dated 15 December 1994. It was required to be embodied before 31 March 1995. The reason for the modification was described as: 'Due to the lack of maintenance or because of wear, the locking hook on the tailplane attachment bracket became disengaged in a number of cases, so that the horizontal tailplane was no longer securely attached to the fin.' The actions required by TN 278-36 included: 'Re-adjustment of the set screws on the tailplane attachment bracket to eliminate any tangential play ... Installation of a safety device [pin] for the locking lever... Check of the rigged and secured horizontal tailplane for full and free movement up to the stops.' It did not stipulate any amendments to the existing rigging instructions in the flight manual. An illustration from TN 278-36 is shown in Figure 8.

Tailplane attachment and control connection from TN 278-36 showing addition of a metal bracket and safety pin

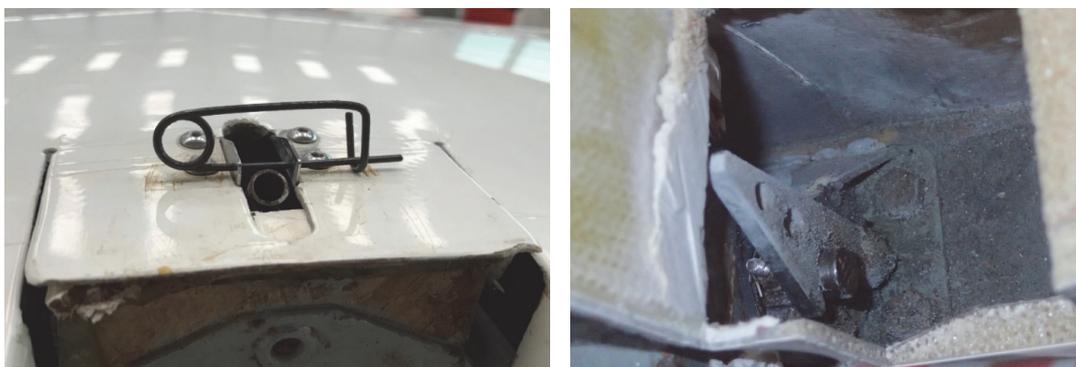
**Figure 10**

When the tailplane was attached to the fin, an audible 'clunk' was heard as the mechanism engaged, as described in the flight manual. The locking lever came to rest directly in-line with the attachment hole for the safety pin and the safety pin could not be inserted without first moving the locking lever. To correctly secure the tailplane the locking lever is moved aft to the (fully locked) position (Figure 10).

Position of locking lever and locking hooks in fully aft (locked) position.  
Note: only right hook shown
