ACCIDENT

Aircraft Type and Registration:	Scheibe Super Falke SF25E, G-KDEY
No & Type of Engines:	1 Limbach SL 1700-EA1 piston engine
Year of Manufacture:	1976 (Serial no: 4325)
Date & Time (UTC):	23 March 2020 at 1651 hrs
Location:	Aston Down Airfield, Gloucestershire
Type of Flight:	Private
Persons on Board:	Crew - 1 Passengers - None
Injuries:	Crew - 1 (Serious) Passengers - N/A
Nature of Damage:	Destroyed
Commander's Licence:	Private Pilot's Licence
Commander's Age:	72 years
Commander's Flying Experience:	3,446 hours (of which 344 were on type) Last 90 days - 1 hour Last 28 days - 1 hour
Information Source:	AAIB Field Investigation

Synopsis

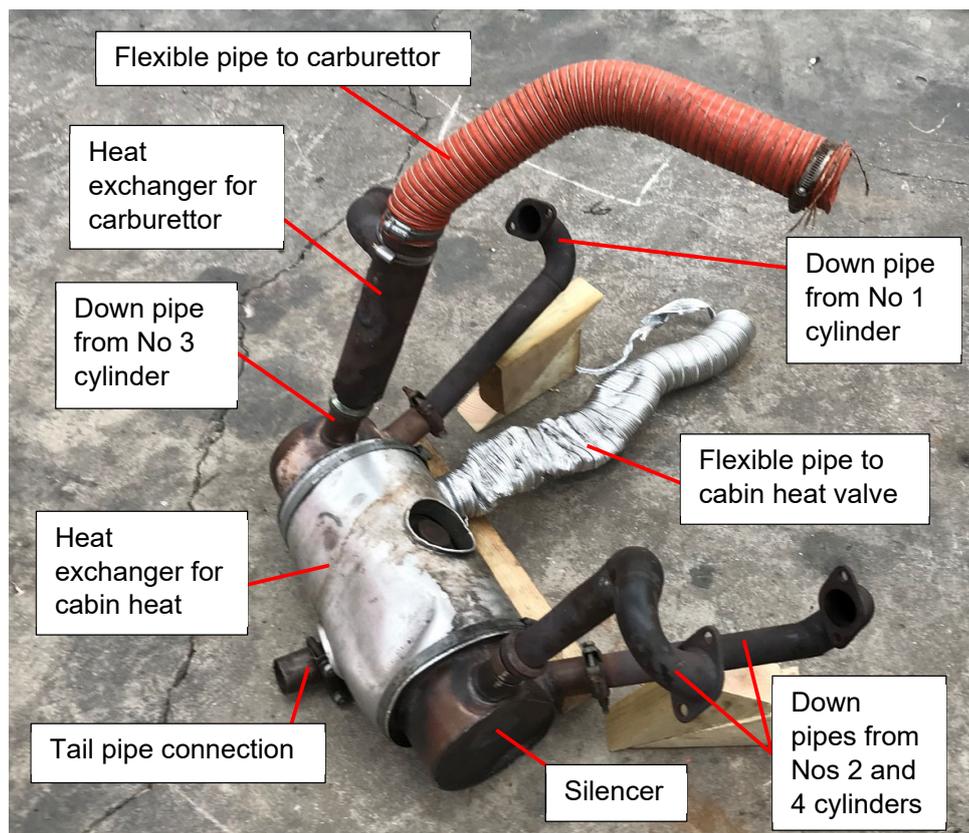
Figure 6
G-KDEY exhaust system

The investigation found that carbon monoxide had been leaking from the exhaust and is likely to have impaired or rendered the pilot unconscious before the aircraft hit the ground.

The exhaust consists of a silencer positioned directly under the engine and connected to each of the engine's four exhaust ports by down pipes. Exhaust gasses pass from the piston combustion chambers, through the down pipes to the silencer and are vented rearwards to atmosphere underneath the aircraft by a tail pipe. To make use of the heat from the exhaust, a heat exchanger is fitted around the silencer. Atmospheric air from the front of the engine cowling passes into the heat exchanger and is warmed by the silencer (Figure 6).

The report highlights the EASA and CAA guidance on maintenance of piston engine exhaust systems to reduce the risk of carbon monoxide poisoning and the options available in selecting carbon monoxide detectors for General Aviation aircraft. A CAA safety leaflet and EASA report also highlights the issues associated with the use of Mogas and the increased risk of carburettor icing due to the ethanol content.

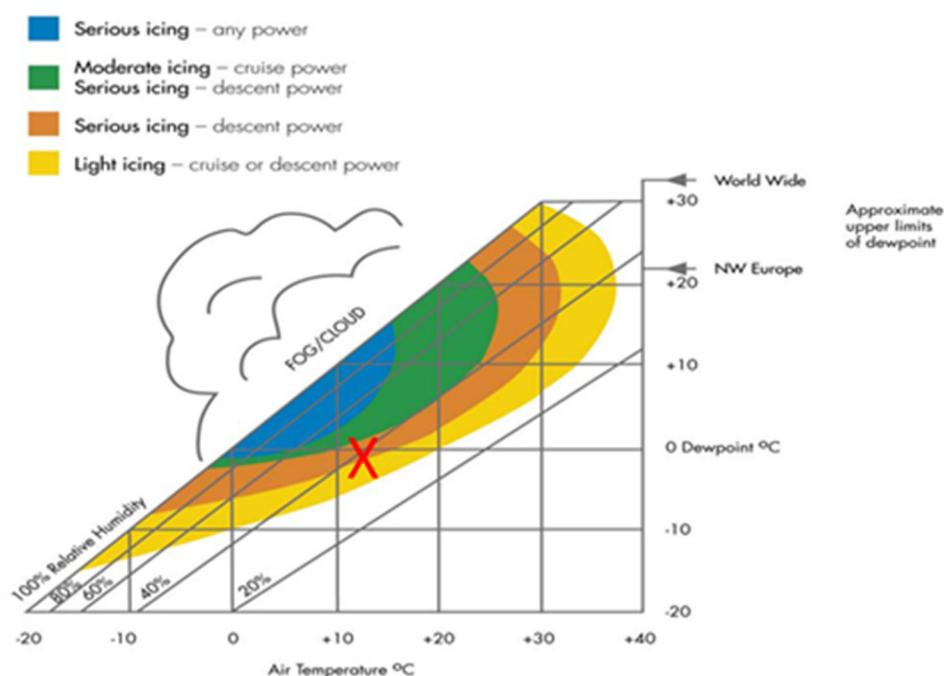
Figure 12
Carburettor Icing Chart

Observations at Gloucestershire Airport, approximately 11 nm north of the accident site, at the time of the accident indicated that the wind was from 140° at 5 kt. The visibility was in excess of 10 km, the temperature was 13°C and the dew point -1°C. The atmospheric pressure was 1024 hPa. When plotted on the CAA's carburettor icing chart they indicate that there was a likelihood of serious icing with descent power (Figure 12).
