ACCIDENT

Aircraft Type and Registration:	Silent 2 Electro, G-CIRK	
No & Type of Engines:	1 FES electric motor	
Year of Manufacture:	2013 (Serial no: 2054)	
Date & Time (UTC):	23 April 2021 at 1305 hrs	
Location:	Wormingford Airfield, Colchester, Essex	
Type of Flight:	Private	
Persons on Board:	Crew - 1	Passengers - None
Injuries:	Crew - 1 (Serious)	Passengers - N/A
Nature of Damage:	Aircraft destroyed	
Commander's Licence:	Light Aircraft Pilot's Licence (Sailplanes)	
Commander's Age:	71 years	
Commander's Flying Experience:	295 hours (of which 55 were on type) Last 90 days - 13 hours Last 28 days - 13 hours	
Information Source:	AAIB Field Investigation

Synopsis

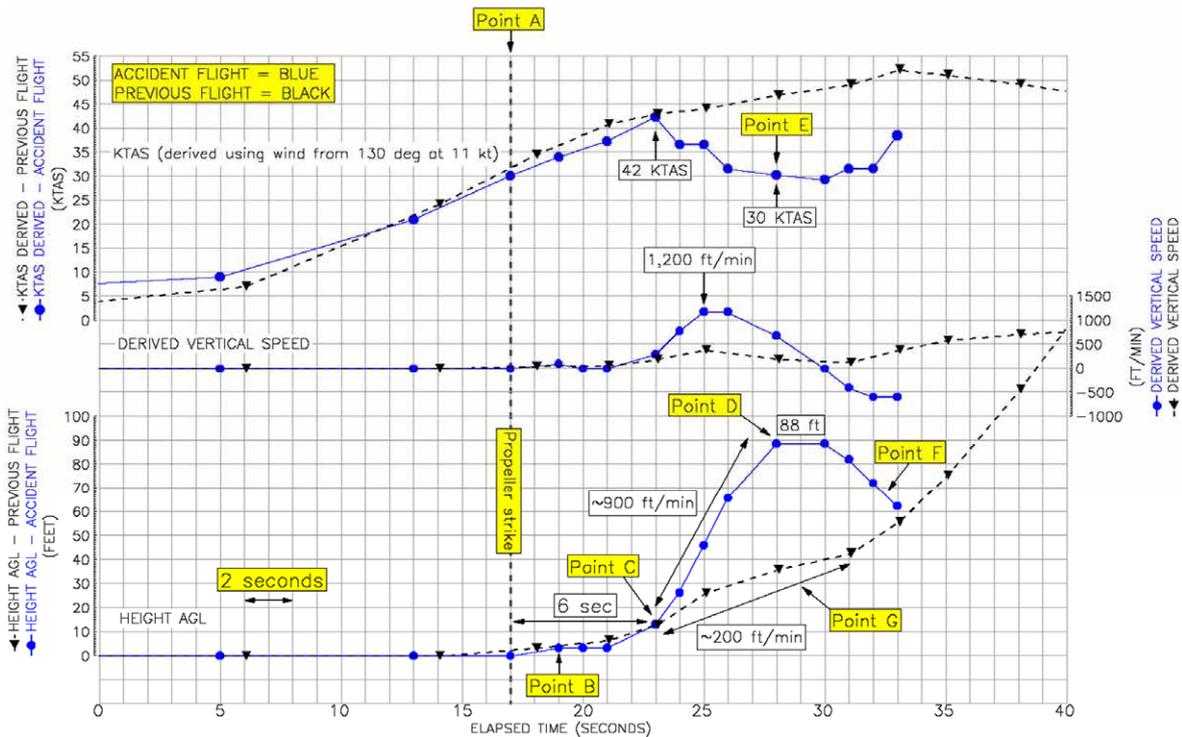
Figure 3

The recorded data, in conjunction with witness marks on the runway, showed that approximately 12 seconds after the pilot had started the takeoff run, G-CIRK's propeller struck the surface of the runway (Figure 3 and Figure 4 Point A). However, this did not appear to adversely affect its acceleration and two seconds later, the data indicates that it may have then lifted off but remained close to the runway surface for several seconds whilst it continued to accelerate (Figure 3 and Figure 4 Point B).

About six seconds after the propeller strike, G-CIRK was recorded at a height of about 15 ft agl and its estimated airspeed was 42 KTAS (Figure 3 and Figure 4 Point C). It then climbed for the next six seconds at an average rate of 900 ft/min, while also deviating to the left of runway track by about 12° (Figure 4). As the aircraft climbed, its airspeed also gradually reduced. The trajectory of the aircraft, based on the maximum recorded height of 88 ft agl (Figure 3 and Figure 4 Point D), indicates that it climbed to about 100 ft agl, at which point its airspeed was about 30 KTAS (Figure 3 and Figure 4 Point E). The glider then descended. The last data point was recorded when the glider was at about 40 ft agl and its rate of descent was 500 ft/min (Figure 3 Point F). The glider subsequently struck the ground, 36 m laterally from the last data point.

Comparison of the accident takeoff and the previous self-launch takeoff showed that the aircraft's acceleration during the takeoff roll, and its airspeed during the first few seconds of the climb, were similar. However, the climb profiles then diverged. During the previous takeoff, the initial rate of climb was maintained at about 200 ft/min (Figure 3 Point G) until the glider's airspeed had reached 50 KTAS, after which, the climb rate increased to about 430 ft/min.

GPS derived data for accident and previous self-launch takeoff

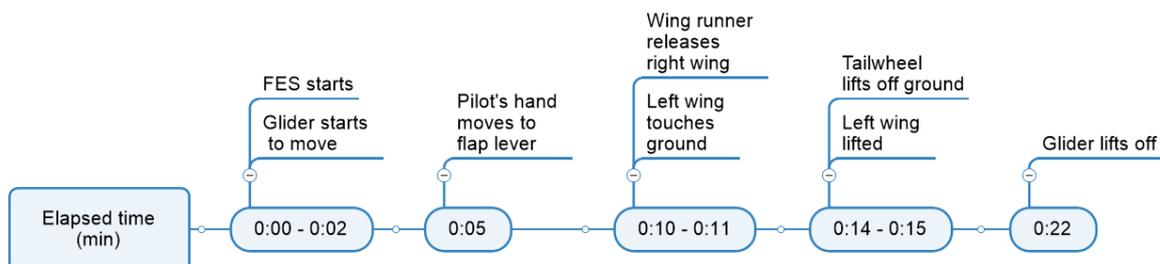
Figure 5
Timeline of the pilot’s previous self-launch takeoff

The video of the pilot’s previous takeoff showed that approximately three seconds after the glider started to move, the pilot transferred his left hand from the instrument panel mounted FES control unit onto the flap lever (Figure 5). The flap lever appeared to be in the flap +1 position but the angle from which the footage was taken meant that this could not be positively confirmed. After a further five seconds, the wing tip runner released the right wing and the glider immediately started rolling left over a period of one second, until the left wing touched the ground. G-CIRK’s tail wheel lifted off the ground three seconds later, just before the glider rolled right into a wings level attitude. During the following six seconds, some minor oscillations were noted in all axes but the pilot appeared to correct these. The glider then lifted off and climbed in a nose up attitude to a height of about 30 ft agl, before the nose was lowered slightly, to what appeared to be an almost level pitch attitude, and a shallower climb was established. The video ended when the glider was at a height of about 45 ft agl.

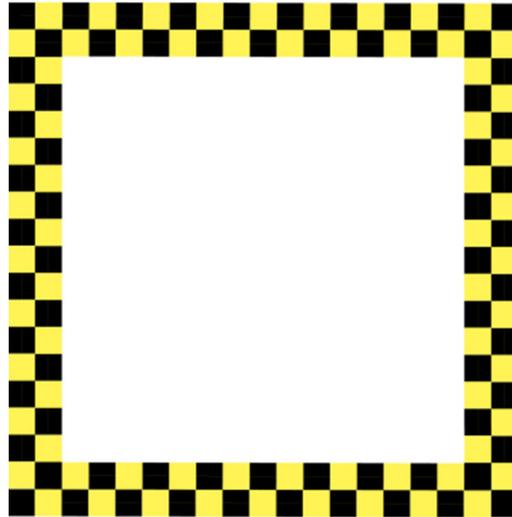
Figure 15

Two placards were affixed to the fuselage aft of the cockpit to warn people about the hazards from the rocket and parachute (Figure 14). These placards conformed to the requirements in ASTM F2316-12²⁸. They did not conform to the placard requirements in BCAR Section S²⁹, sub-section K on 'Microlight Parachute Recovery Systems', which require the 'DANGER' placard to be larger than that specified in ASTM F2316-12³⁰, and which also require a double offset black and yellow chequered line to surround the parachute and rocket exit area (Figure 15). As an SSDR the Silent 2 Electro is not required to meet BCAR Section S; however, the CAA published Skywise article SW2021/91³¹ on 29 April 2021 which stated that: 'The CAA strongly recommends that owners of SSDRs fitted with a BPRS comply with the requirements of BCAR Section S, Sub-Section K, to clearly identify the presence of the BPRS to emergency services and first responders in the event of an accident.'

From BCAR Section S, sub-section K, sample of double offset black and yellow chequered line which should surround the parachute and rocket exit area
