CAA and EASA Airworthiness Directives (ADs) all owners notified.

Safety Information

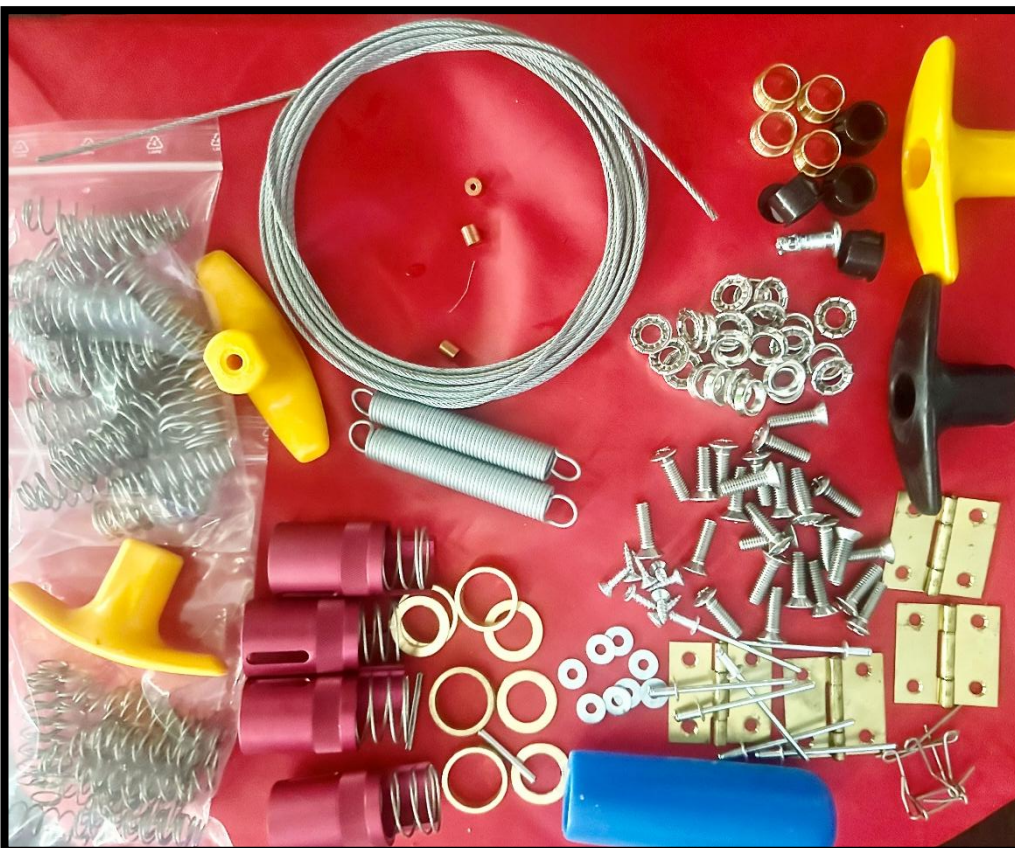
13 Schempp Hirth spares shop

A lot of owners and some inspectors are not keen to change parts because of the perceived difficulty and cost of getting those parts. This is my experience of giving my 51-year-old Std Cirrus some long overdue love. The Schempp Hirth web shop says they do not deliver outside the EU, but when I emailed them my shopping list, they said they did

ship to the UK. I paid by credit card and had the parts in 4 days.

- 4 Wedekind fittings
- 4L'Hotelier locking springs
- New airbrake cap springs
- New U/C door Hardware
- New Nico press release/rudder cable adjustment (and ferrules)
- New T handles (with spares for my other gliders)
- New seat pan screws and washers
- Seat back Dzus fastener
- Airbrake handle
- 2 sets of tailplane bushes.

Total cost with VAT £436.19 and most of that was the Wedekind fittings.
